Inspection Report

Property Address:
12345 Undisclosed Address
Great Falls VA 22066

Jeff Pearce Home Inspector Lic#29830
15922 A.E. Mullinix Road
Woodbine Md. 21797
410-984-1215

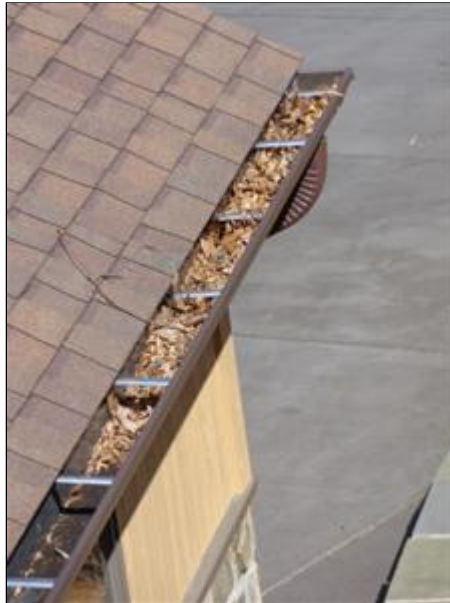
1.3 Picture 1 front of home

1.3 (1) The gutters are clogged with leaves and debris and pond water. Clean out these gutters and keep free flowing. Consider gutter guards to keep the leaves out in the future.

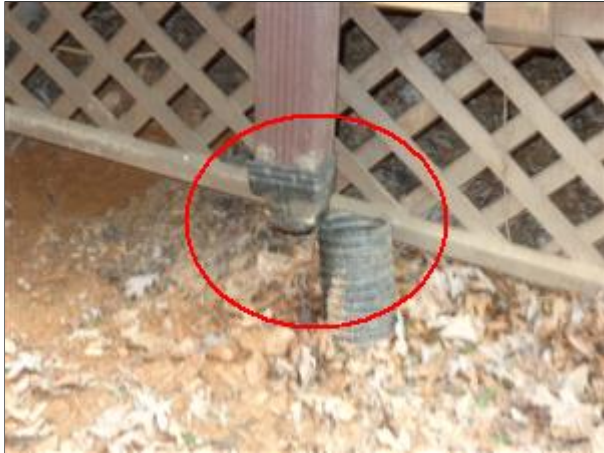
(2) The left side down spout extension is missing the extension and draining down the foundation wall. Re-attach this drain to move water away from the foundation.

1.3 Picture 2 left side

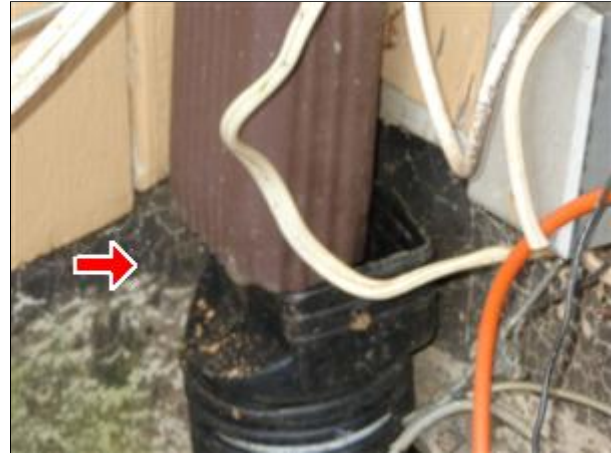
1.3 Picture 3 left side

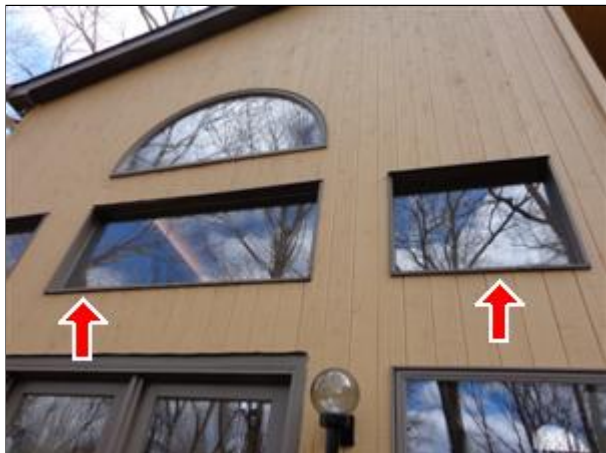
2.0 (1) I observed many areas around the exterior of the home where trim and door need scrape/sanding then a fresh coat of paint. Bare wood becomes exposed to the elements and if not protected will rot over time.

2.0 Picture 1 these windows both sides

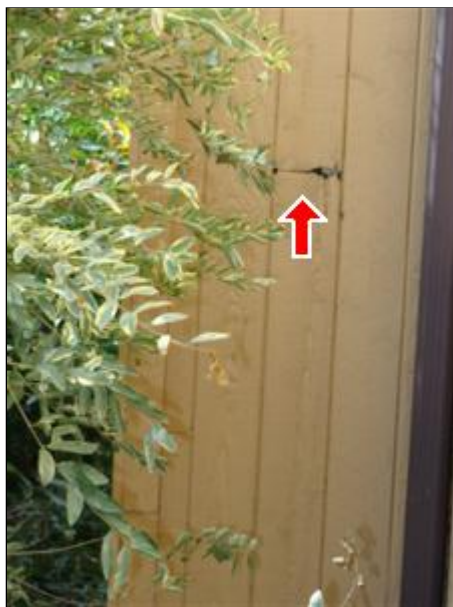
2.0 Picture 3 trim on fireplace left side of home rot

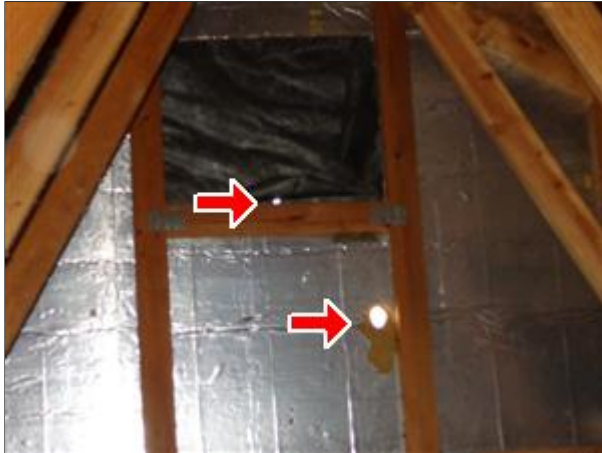
2.0 Picture 4 two holes viewed in attic

(2) Two holes exist on right side gable end of home. The holes were viewed in the attic and also on the outside of home. These holes allow animal and insect entry have them sealed up.

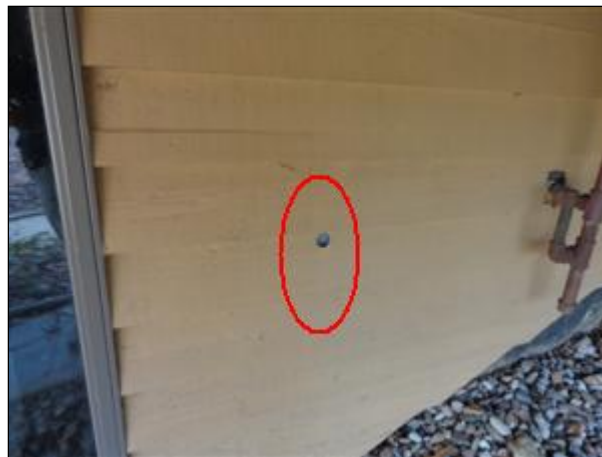
2.0 Picture 6 also hole left rear

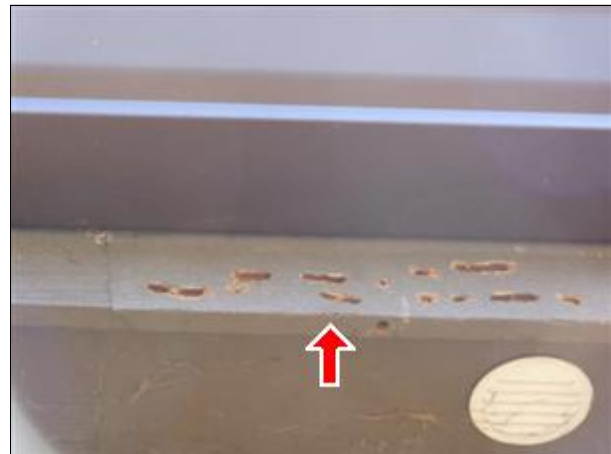
(3) Carpenter bees were observed in the front trim of home. Of all wood destroying insects they do very little structural damage however the holes should be treated and wood putty installed. Seek a Pest Control Company and a General Contractor.

2.0 Picture 8 right rear of home several places

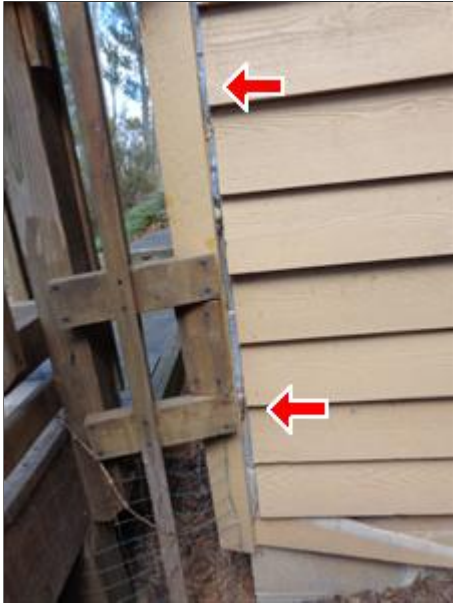
(4) The right rear gate is pulling the siding off the corner of the home. This allows water entry to the framing wood. Have this repaired by a general contractor.

2.0 Picture 9 gap here

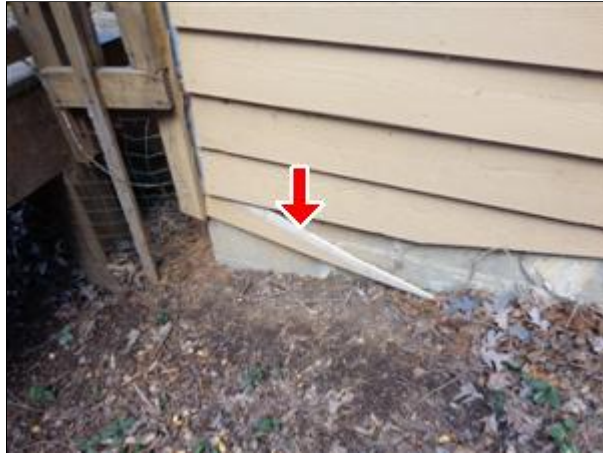
2.0 Picture 10 loose siding

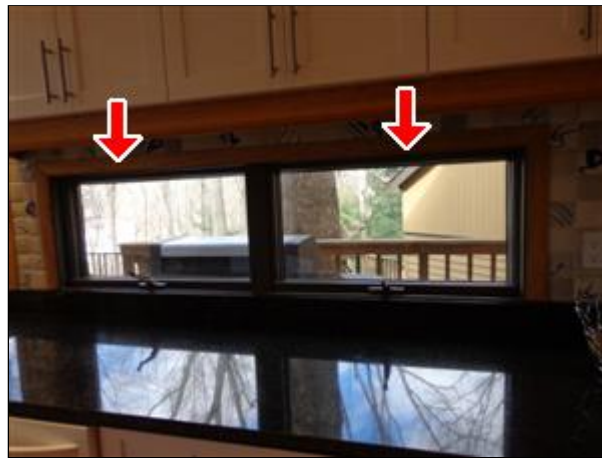
2.2 (1) The windows at kitchen would no open have them evaluated and repaired as needed by a general contractor.

2.2 Picture 1 wont open

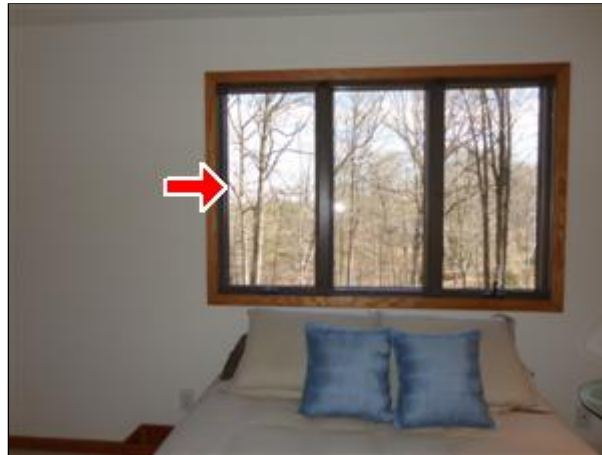
(2) The upper right bedroom left side casement window wont wind back in when opened have it repaired as needed for proper operation.

2.2 Picture 2 this window

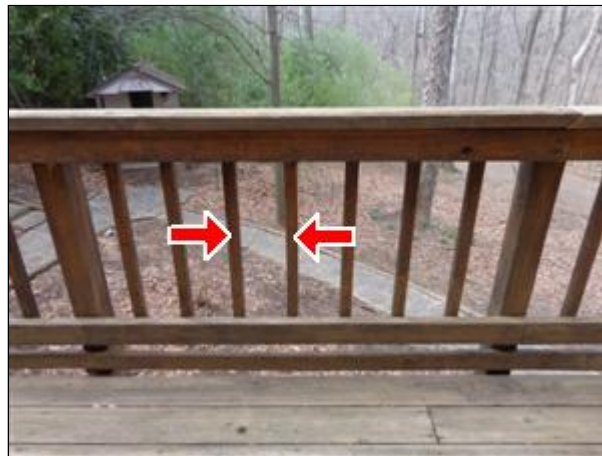
2.3 Open spaces greater than four inches on pickets and stairs are not permitted by current code and are a hazard to children and pets. Although this may have been permitted when the deck was built we advise bringing to current standards for safety.

2.3 Picture 1 larger than 4"

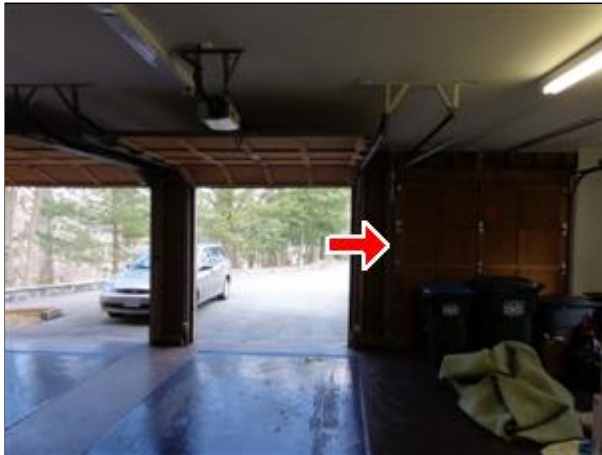
3.5 The garage door openers are in place but are not operational on left side door. The motor catch plate is not attached to the retractor chain. Have it repaired or replaced as needed.

The right most garage door would not reverse when met with resistance. This door has no modern electronic eyes for safety. Consider replacing with modern garage door opener to meet current safety standards.

3.5 Picture 1 wont open

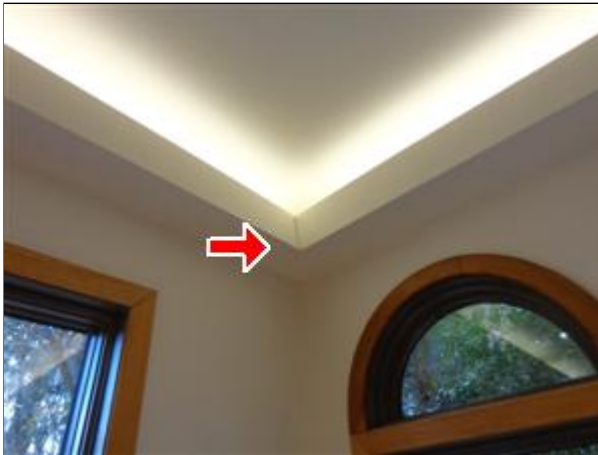
4.0 Picture 1 cracks here

4.0 The ceiling and walls consist of small hairline cracks and settlement in owners bedroom ceiling of the home. These areas will need to be pointed up prior to painting in the future

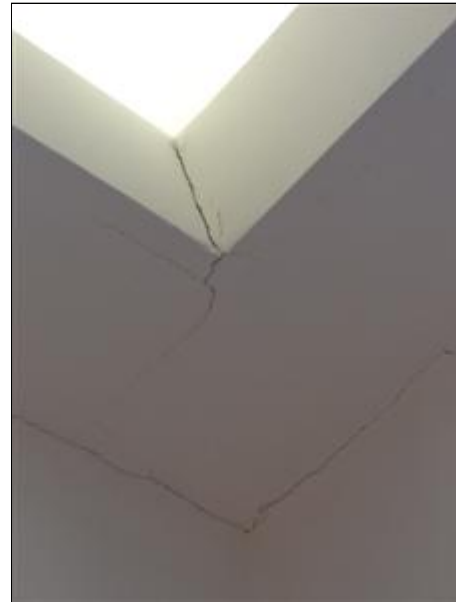
4.0 Picture 2 close up

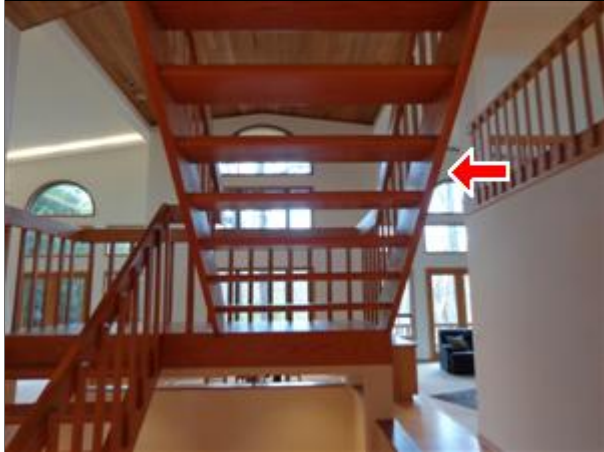
4.3 The stairs have open spaces greater than 4" which is no longer permitted by code as they are a hazard to children who can fall thru. Have a general contractor give options on repairs to bring up to current code.

4.3 Picture 1 open spaces

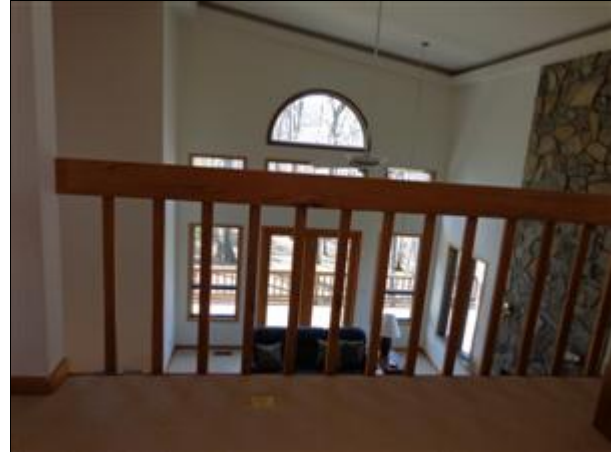
4.3 Picture 2 upper railings

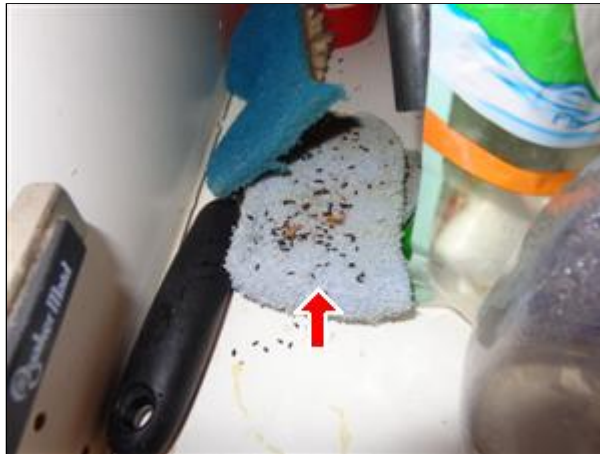
4.4 Picture 1 mice feces

4.4 I observed mice droppings in the bottom of the kitchen sink cabinet. The area was recently sealed with foam where pipes come through cabinet. Have this evaluate and seal as needed to stop mice.

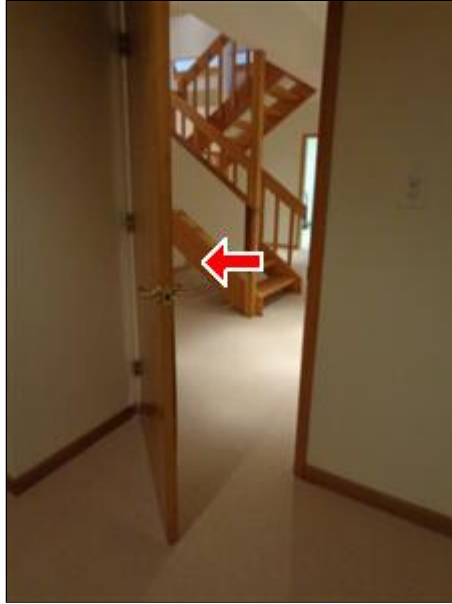
4.5 (1) Trim adjust the basement door at bottom of stairs basement catch plate to close and latch properly. Also this door is hinge bound and wont close.

4.5 Picture 1 door wont close easily

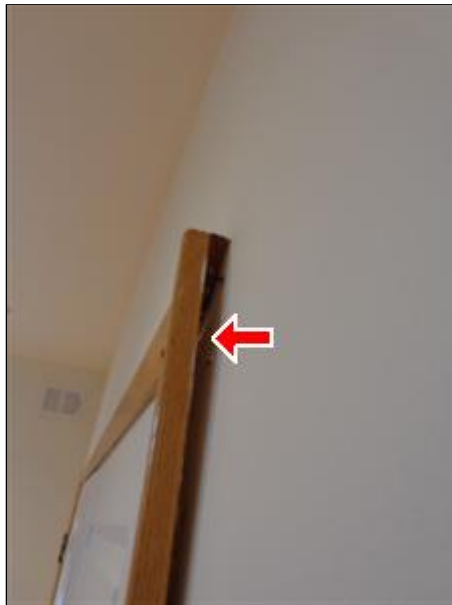
(2) The trim on front door right side is loose have it attached as desired.

4.5 Picture 2 trim loose

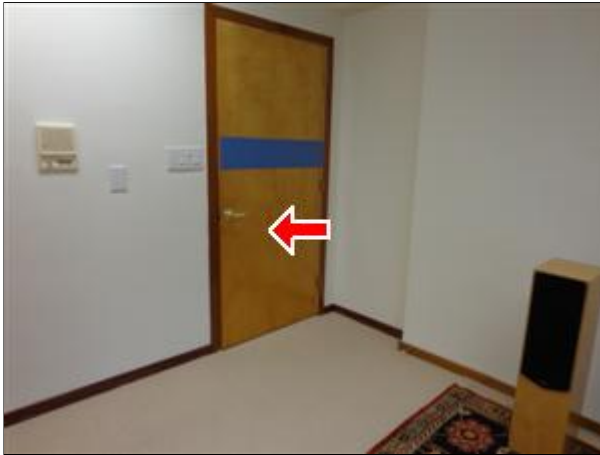
(3) Trim adjust the basement rear room doors catch plate to close and latch properly.

4.5 Picture 3 not meeting catch plate

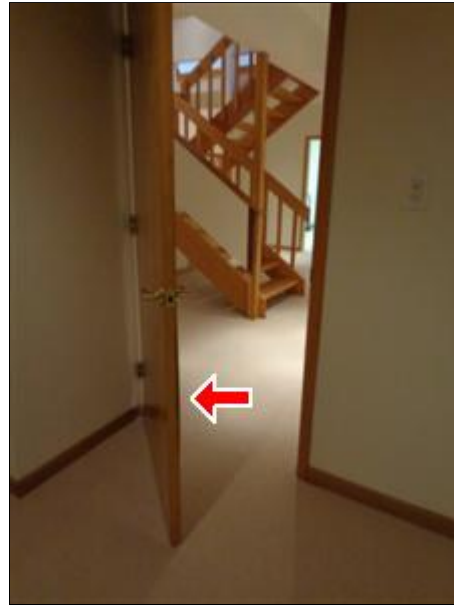
Also this door is de-laminating its outer skin have it repaired as needed.

4.5 Picture 4 door de-laminating

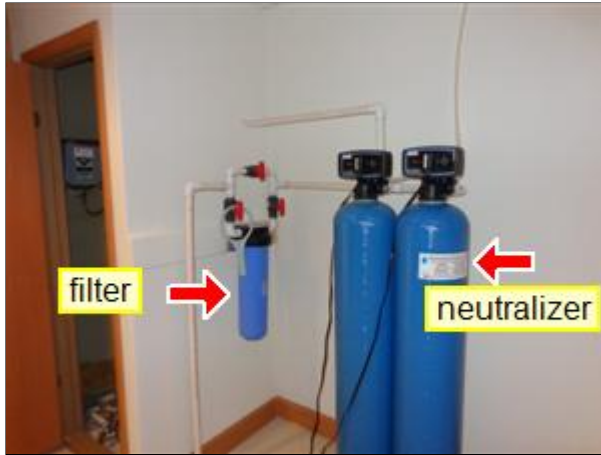
6.0 Picture 1 view of equipment

6.0 (1) You have two pieces of water treatment equipment located in the basement. The Neutralizer will require annual maintenance including adding calcium coroset to bring the water from acidic to basic. The unit is operated by an extension cord which is ok but preferred to be hard wire to a receptacle within the room.

In addition, you have a whole house filter that will require replacement periodically depending on the amount of turbidity in the water.

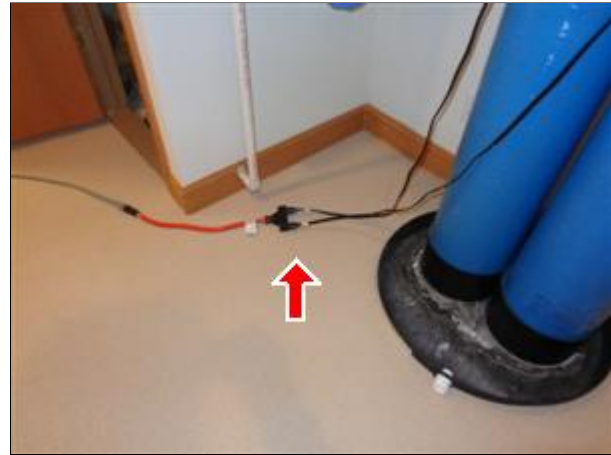
6.0 Picture 2 extension cord

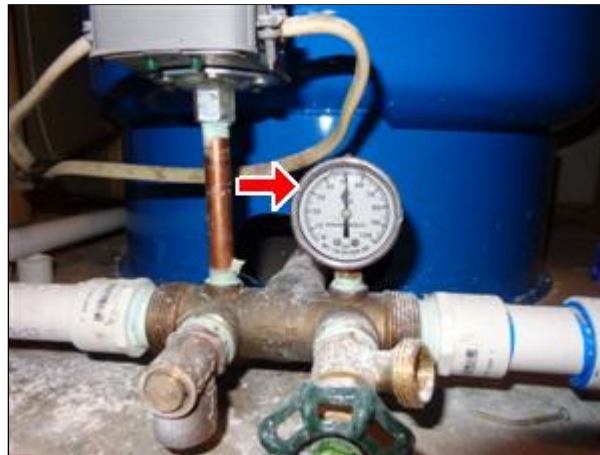
(2) Some water was observed in the site glass of the pressure gauge which indicates the unit may be leaking. Have this evaluated to determine if this was by design or it needs replacement.

6.0 Picture 3 water in gauge

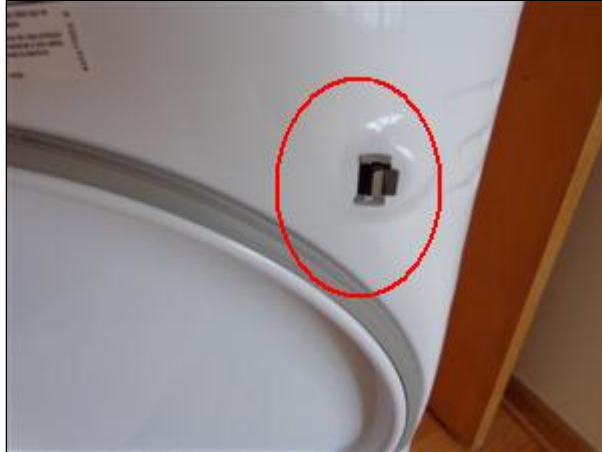
6.0 Picture 4 catch loose in door

(3) The dryer door catch is broken and must be lined up in the middle before door is closed repair as desired.

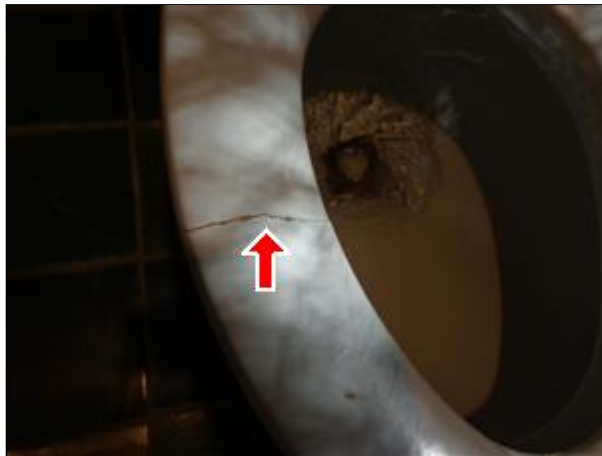
(4) Replace owners bath toilet seat its broke.

6.0 Picture 5 cracked seat

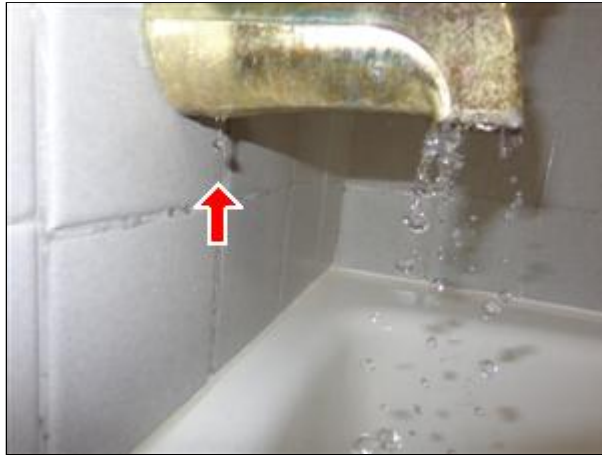
Also the bath diverter is leaking out the bottom in this bathrooms shower replace as needed.

6.0 Picture 6 leaking here

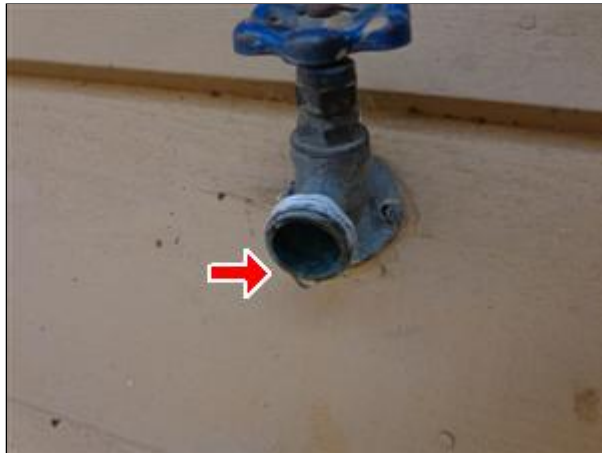
6.0 Picture 7 bib drips

(6) The rear hose bib leaked when turned off. Have a plumber evaluate and repair replace the valve as needed.

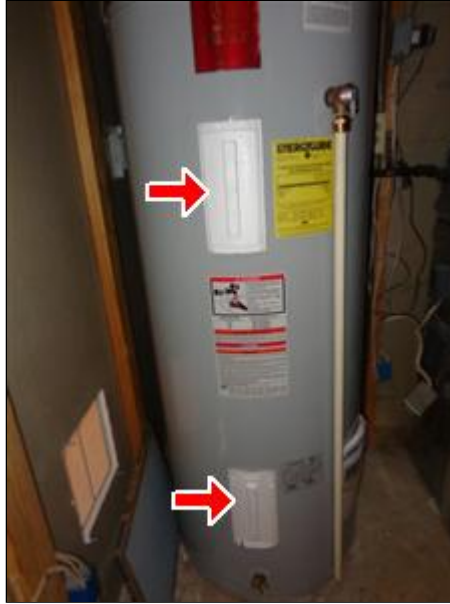
6.1 Picture 1 covers go here and are on top of heater

6.1 The covers are off the elements on the water heater. This indicates they may have been repaired recently or an issue existed. Have these elements evaluated and the covers installed.

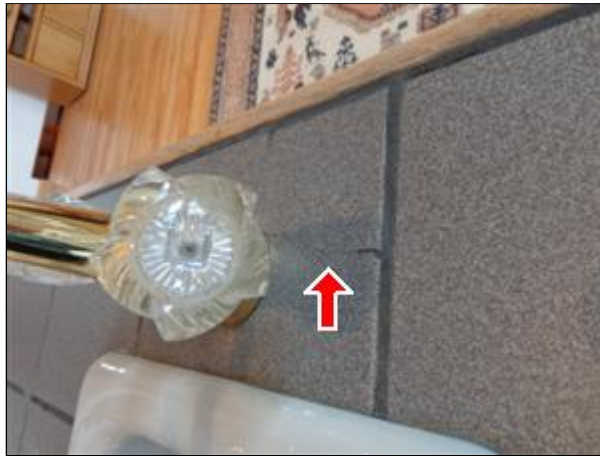
6.6 (1) The tile at bar sink great room is cracked by the faucet repair as desired.

6.6 Picture 1 crack here

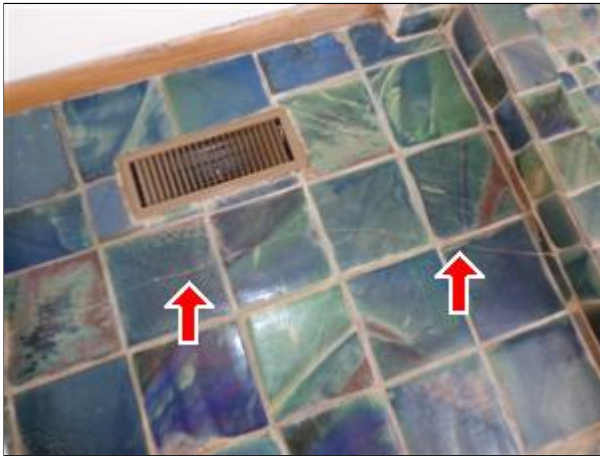
The shower pan tile are cracked in the owners bedroom. Cracked tile in this pan can allow water entry below the tile to the lead liner which can leak to ceiling below. Have general contractor repair replace tile as needed.

I was able to read levels of elevated moisture behind the tile with my moisture meter. If water enters behind the tile via voids in grout it can lead to fungal growth and denigrate the backer board. Although we cannot see its condition underneath the tile we will assume it will need replacing when the tile is replaced.

6.6 Picture 2 floor outside shower

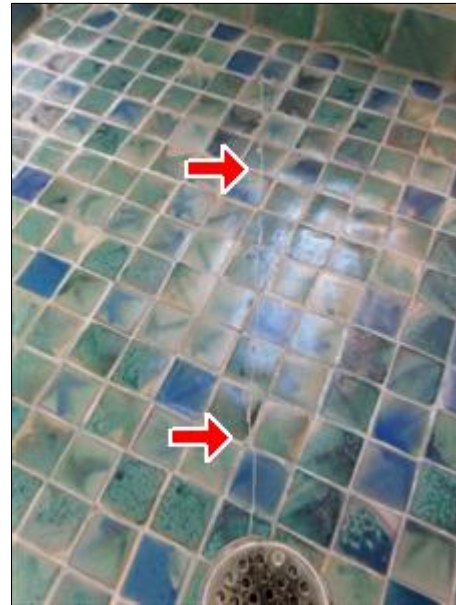
(2) Several of the tile on the shower surround were cracked from settlement. It appears they are large enough to allow water entry behind the wall. Have plumber or tile company repair replace as desired.

6.6 Picture 3 crack in shower

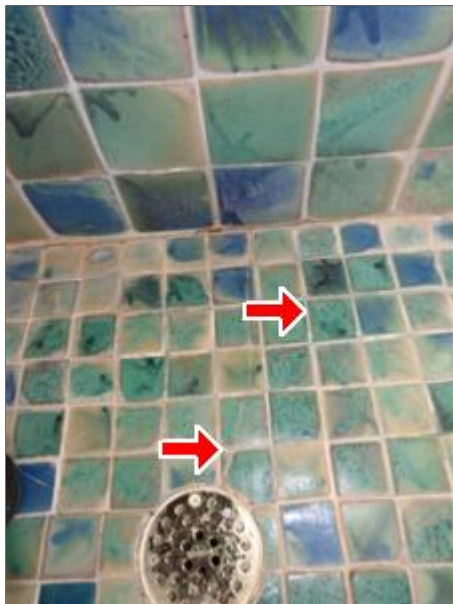
6.6 Picture 4 crack here

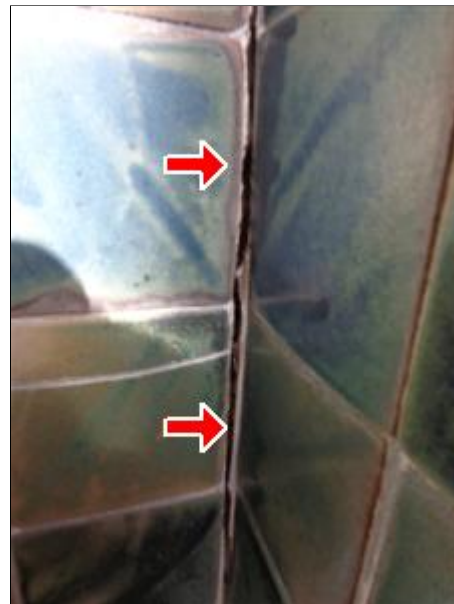
6.6 Picture 5 large void in corner

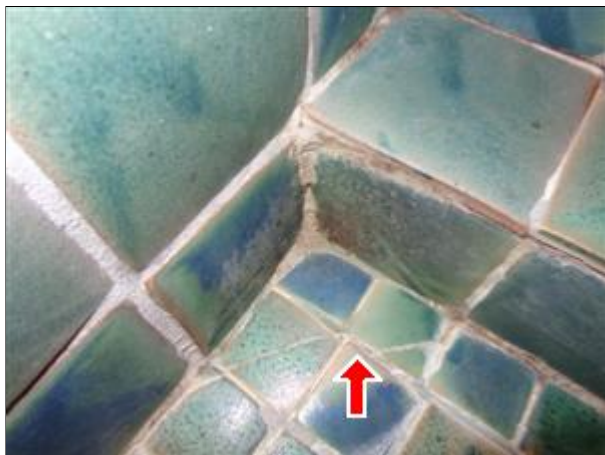
6.6 Picture 6 cracks loose tile

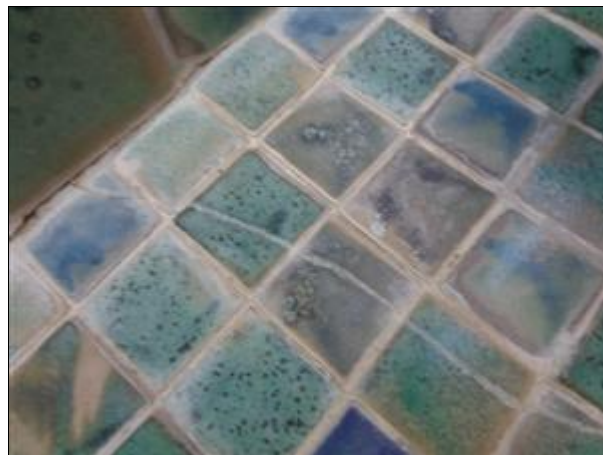
6.6 Picture 7 close up

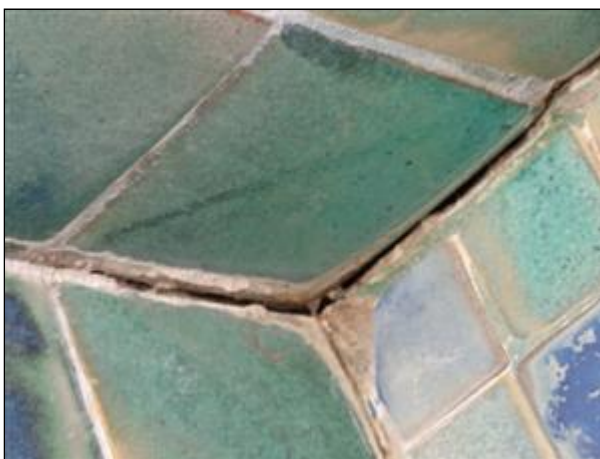
6.6 Picture 8 voids in corner

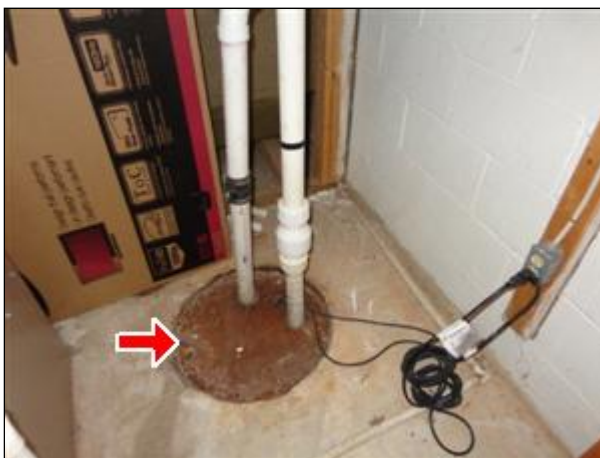
6.7 (1) Due to the sewer being hung and exiting the home five foot above the floor the entire bathroom group fixtures ie toilet, shower, and bar sink have ejector pumps. These pumps eject the sewage up by mechanical means to gravity feed out to the street. Periodically they need maintenance to prevent odors escaping into the home and mechanical pump can fail.

6.7 Picture 1 motor in pit here

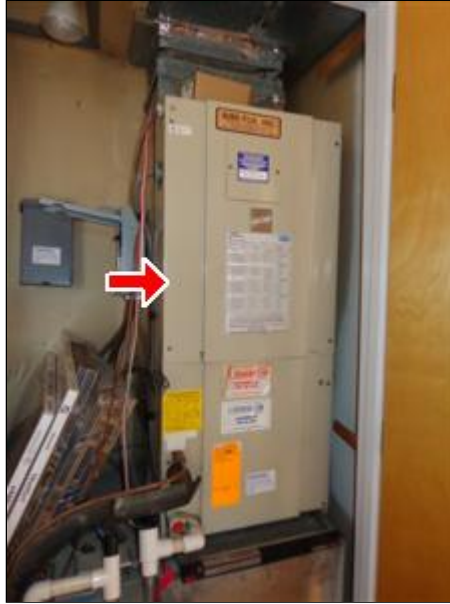
6.7 Picture 2 no overflow pan only
safety on trap

(2) It's recommended that when a water producing appliance such as the second floor fan coil unit is installed over

conditioned space an overflow pan be installed under the appliance with a drain to a conspicuous location that prevents accidental flooding. I recommend one be installed in this location.

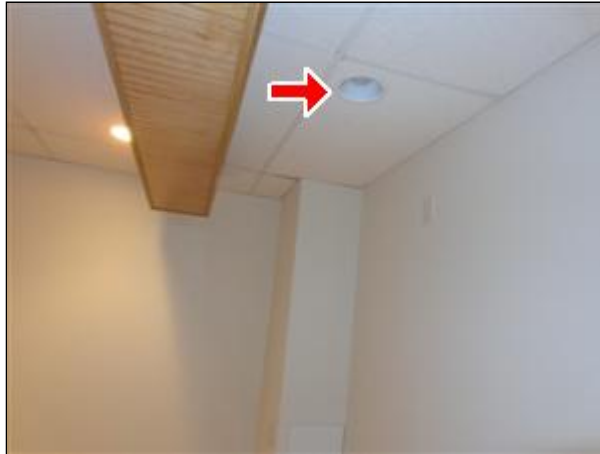
7.3 Picture 1 not working

7.3 (1) The lower level recess light in the water treatment room front right was not operational. This could be as simple fix (replace bulb) or a more serious issue requiring a licensed electrician. Have repaired replaced as needed.

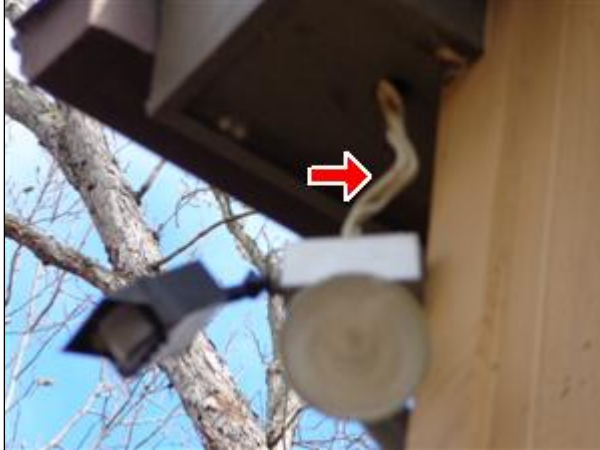
7.3 Picture 2 re-attach here

(2) The upper rear right spot light box came loose from the soffitt and is hanging by its wires repair as needed.

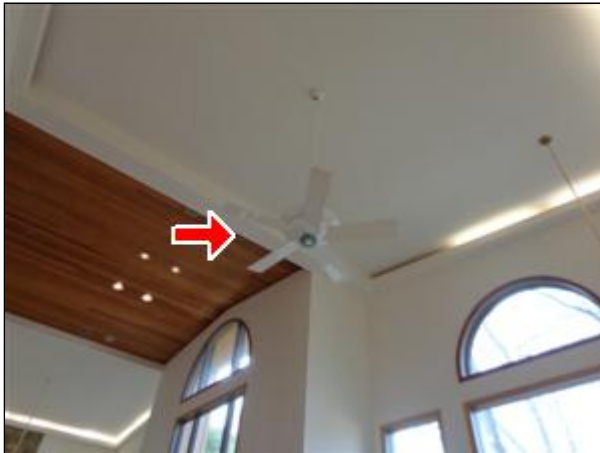
7.3 Picture 3 not working

(3) Both ceiling fan lights were not operational. This could be as simple fix (replace bulb) or a more serious issue requiring a licensed electrician. Have repaired replaced as needed.

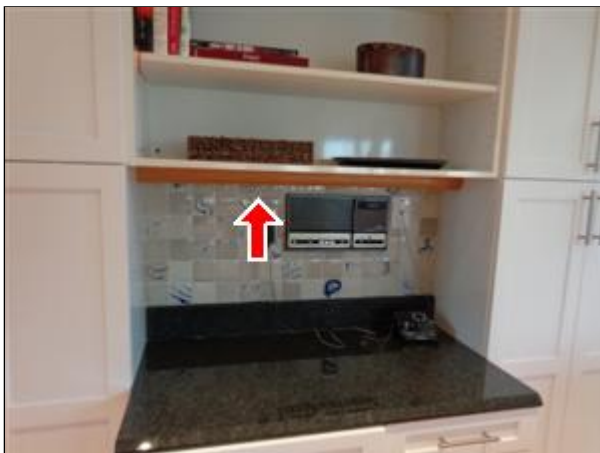
7.3 Picture 4 light not working

(4) The desk area fluorescent light was not operational. This could be as simple fix (replace bulb) or a more serious issue requiring a licensed electrician. Have repaired replaced as needed.

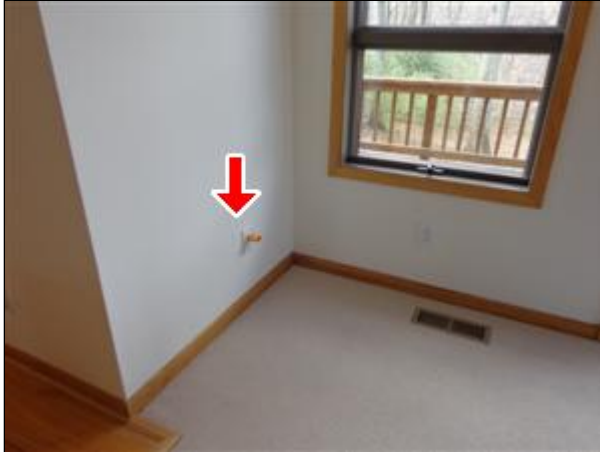
7.4 Picture 1 no power

7.4 The outlet in left side great room was tested and no power was present. Its possible this is on a switch I could not locate. Have an electrician evaluate and repair as needed.

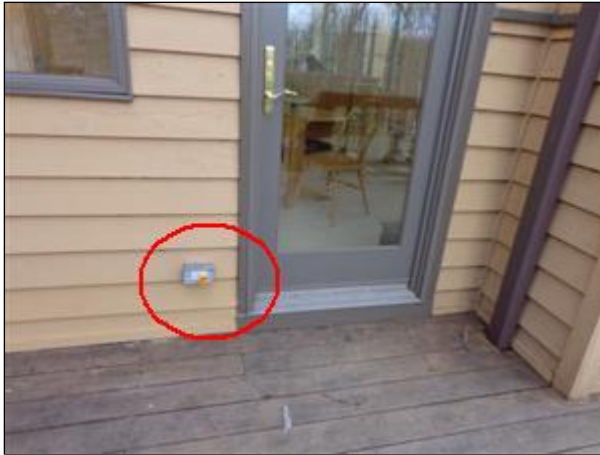
7.5 The outside rear right receptacle is missing its cover replace as needed.

7.5 Picture 1 no cover

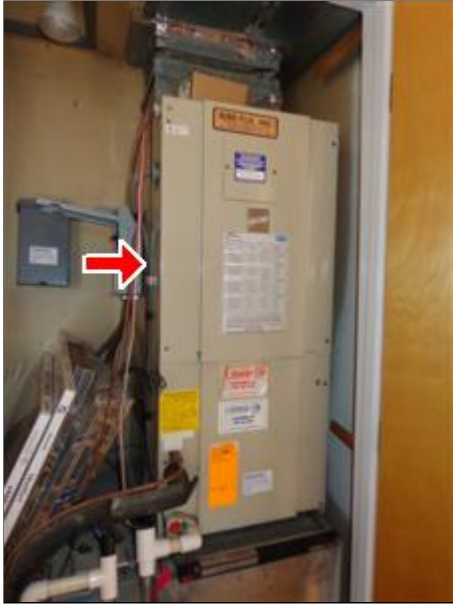
The Heat Pump Zone 2 is 24 years old and is nearing the end of its typical life. Some units last longer than average useful life and some less. Budget to replace in near future.

8.0 Picture 1 zone 2 second floor

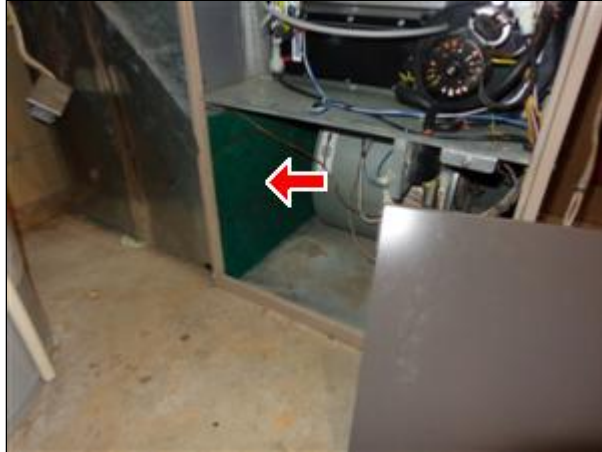
8.1 Picture 1 filter here

8.1 (1) The basement zone gas furnace has a washable filter in the blower compartment that must be cleaned and maintained periodically.

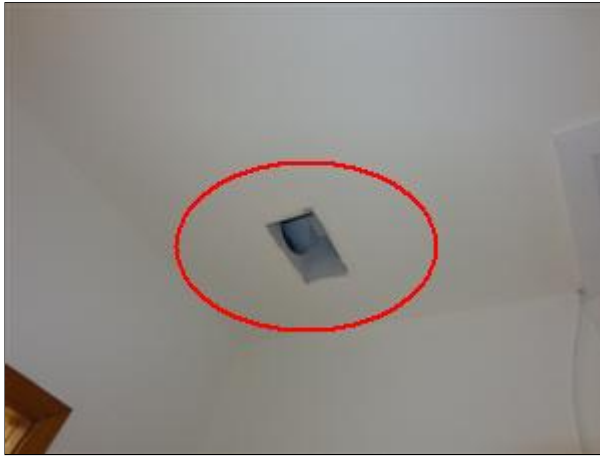
(2) The basement rear left room is missing a register on the ceiling supply have it installed as needed.

8.1 Picture 2 no register

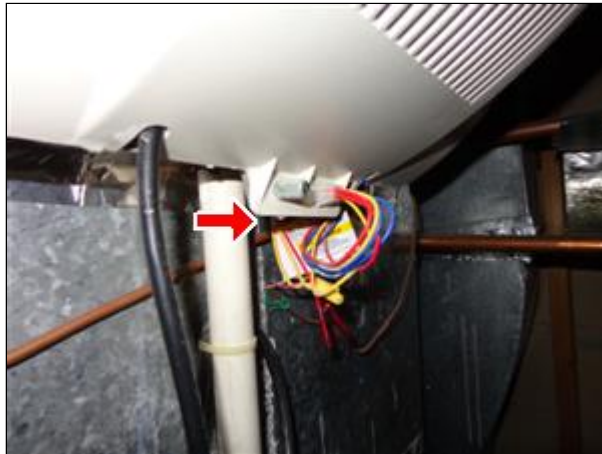
(3) The humidifier was functional but needs to be serviced and a new filter installed for top performance. The unit was leaking slightly when tested from the bottom of the unit. Have this evaluated when filter is replaced.

8.1 Picture 4 leaking here

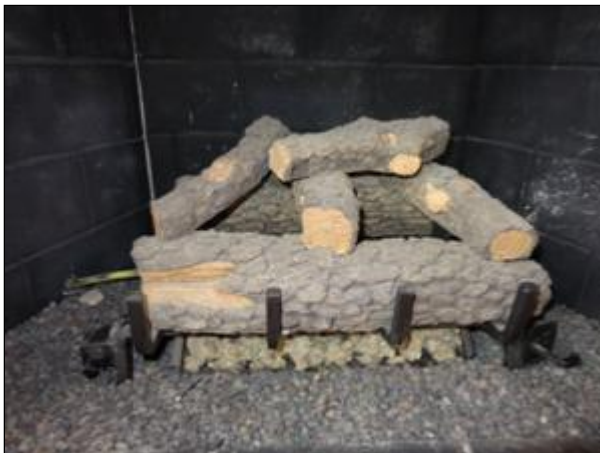
8.4 Picture 1 not working

8.4 (1) I was unable to get the gas log set on right side great room off kitchen to stay lit have them evaluated and repaired replaced as needed.

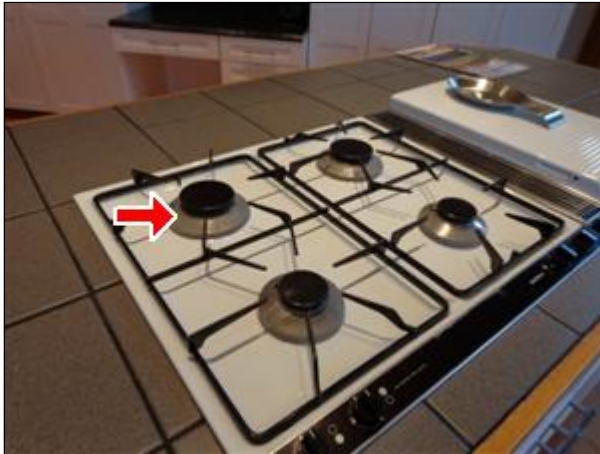
10.1 Picture 1 not lighting

10.1 The left rear stove burner wont light. Have an appliance company evaluate and repair/replace as needed.

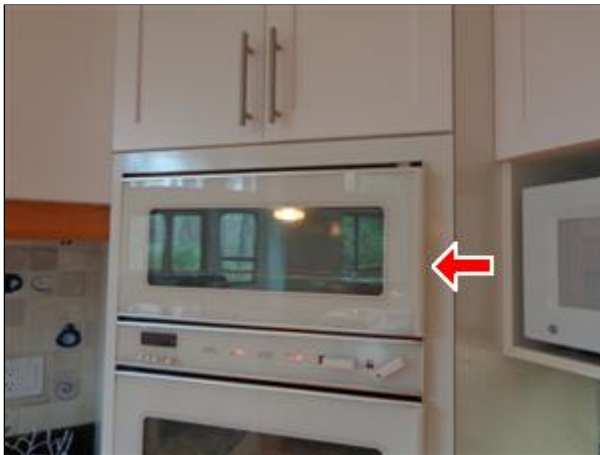
10.4 I had to lift up on the microwave/oven door to get this unit to close and latch properly. Repair as desired.

10.4 Picture 1 hinge sag

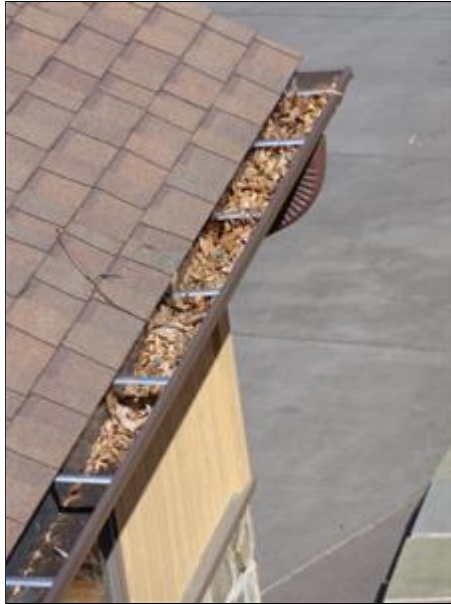
1.3 Picture 1 front of home

(1) The gutters are clogged with leaves and debris and pond water. Clean out these gutters and keep free flowing. Consider gutter guards to keep the leaves out in the future.

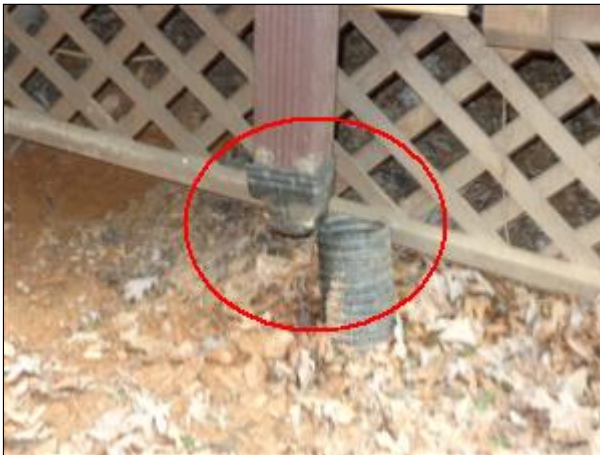
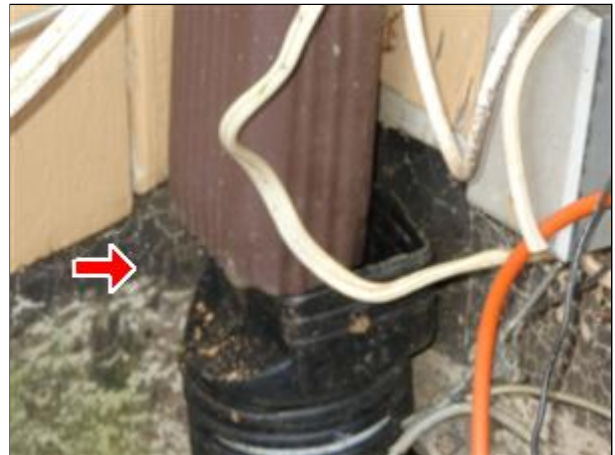
1.3 Picture 2 left side

(2) The left side down spout extension is missing the extension and draining down the foundation wall. Re-attach this drain to move water away from the foundation.

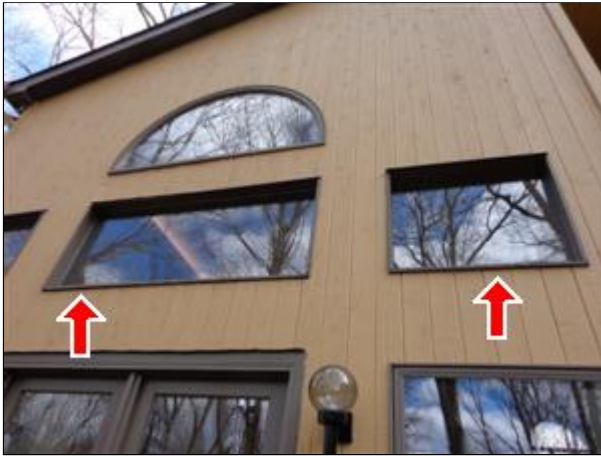
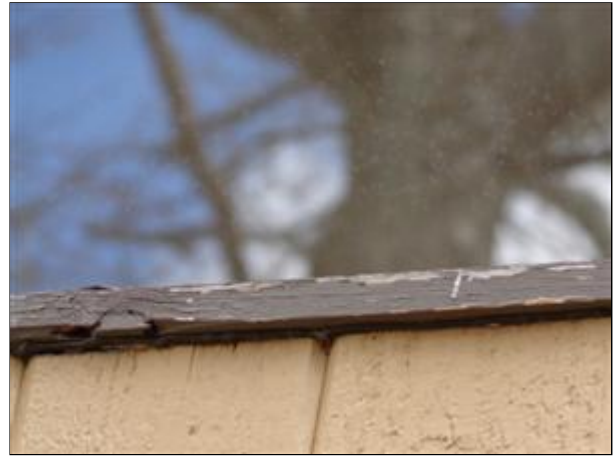
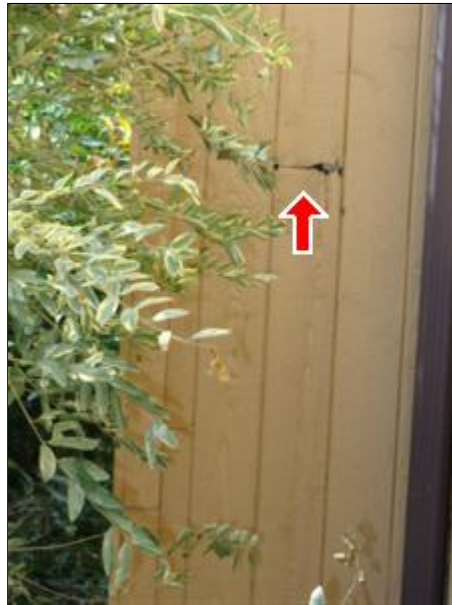
2.0 Picture 1 these windows both sides

(1) I observed many areas around the exterior of the home where trim and door need scrape/sanding then a fresh coat of paint. Bare wood becomes exposed to the elements and if not protected will rot over time.

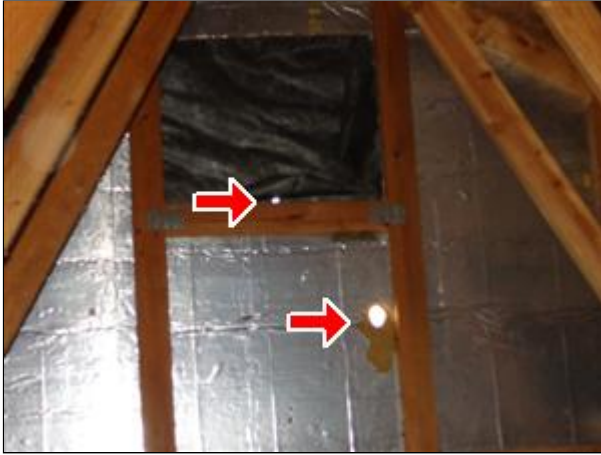
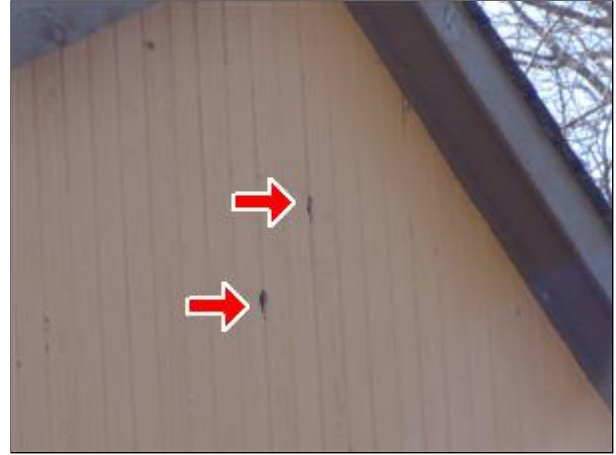
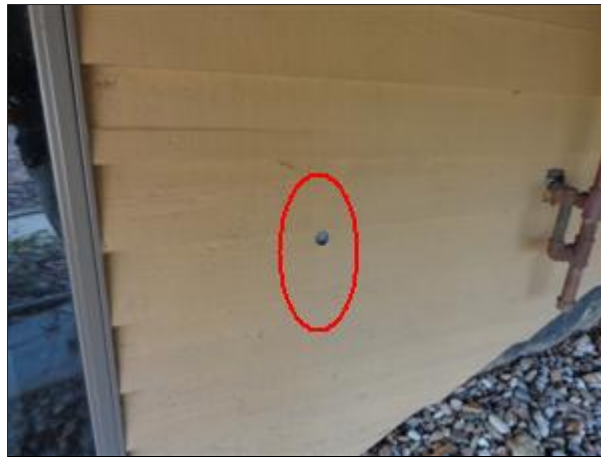
2.0 Picture 4 two holes viewed in attic

(2) Two holes exist on right side gable end of home. The holes were viewed in the attic and also on the outside of home. These holes allow animal and insect entry have them sealed up.

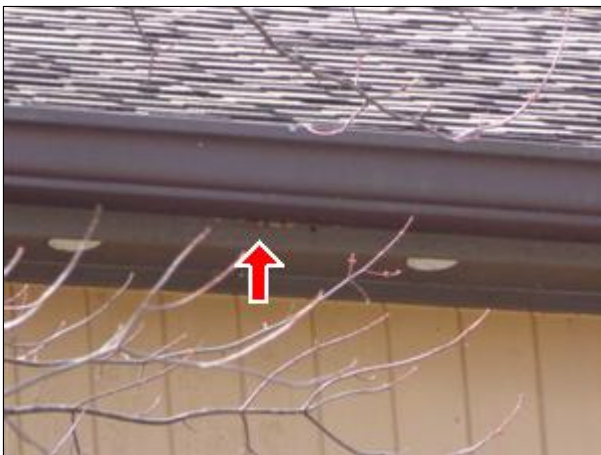
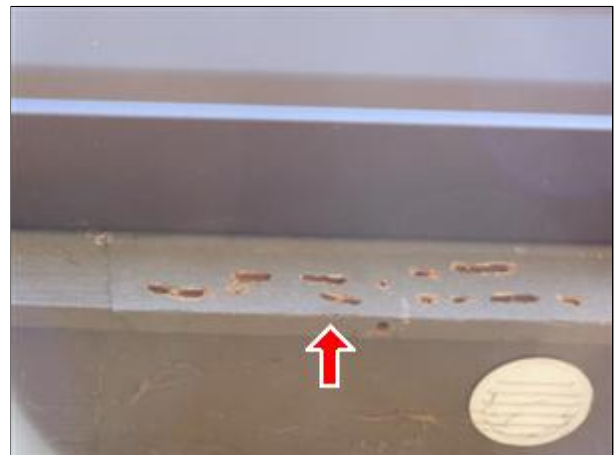
2.0 Picture 7 front left of home

(3) Carpenter bees were observed in the front trim of home. Of all wood destroying insects they do very little structural damage however the holes should be treated and wood putty installed. Seek a Pest Control Company and a General Contractor.

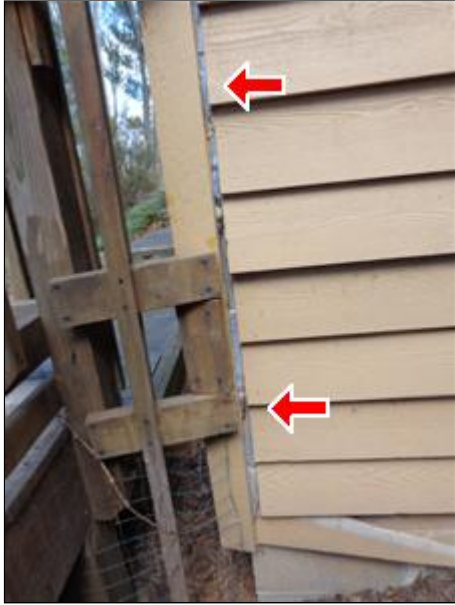
2.0 Picture 9 gap here

(4) The right rear gate is pulling the siding off the corner of the home. This allows water entry to the framing wood. Have this repaired by a general contractor.

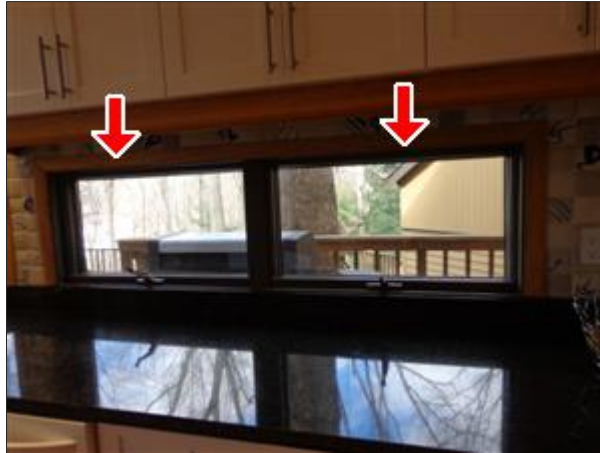
2.2 Picture 1 wont open

(1) The windows at kitchen would no open have them evaluated and repaired as needed by a general contractor.

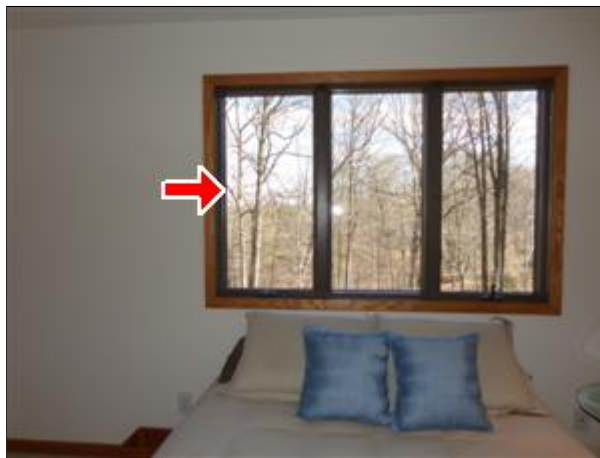
2.2 Picture 2 this window

(2) The upper right bedroom left side casement window wont wind back in when opened have it repaired as needed for proper operation.

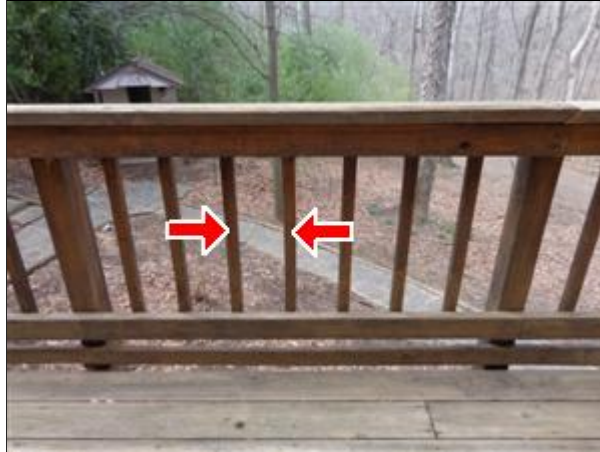
2.3 Picture 1 larger than 4"

Open spaces greater than four inches on pickets and stairs are not permitted by current code and are a hazard to children and pets. Although this may have been permitted when the deck was built we advise bringing to current standards for safety.

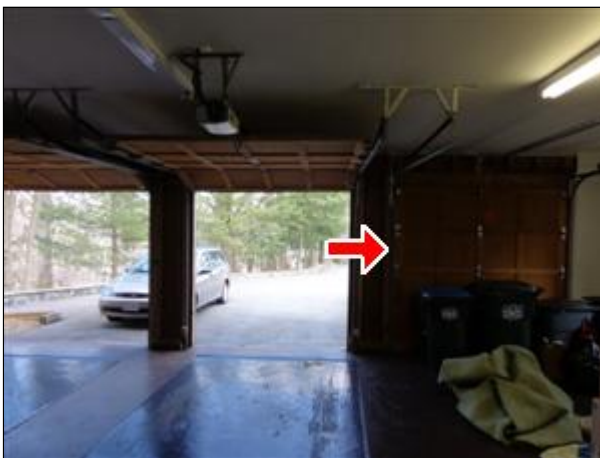
3.5 Picture 1 wont open

The garage door openers are in place but are not operational on left side door. The motor catch plate is not attached to the retractor chain. Have it repaired or replaced as needed.

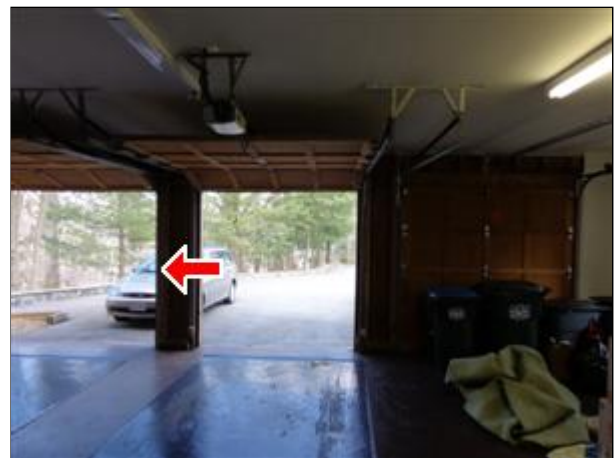
3.5 Picture 2 no safety top

The right most garage door would not reverse when met with resistance. This door has no modern electronic eyes for safety. Consider replacing with modern garage door opener to meet current safety standards.
