Inspection Report

Property Address:
12345 Undisclosed Address
Great Falls VA 22066

Jeff Pearce Home Inspector Lic#29830
15922 A.E. Mullinix Road
Woodbine Md. 21797
410-984-1215

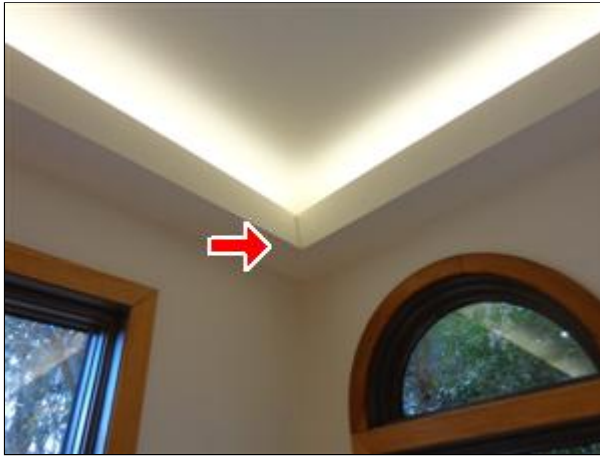
4.0 Picture 1 cracks here

The ceiling and walls consist of small hairline cracks and settlement in owners bedroom ceiling of the home. These areas will need to be pointed up prior to painting in the future

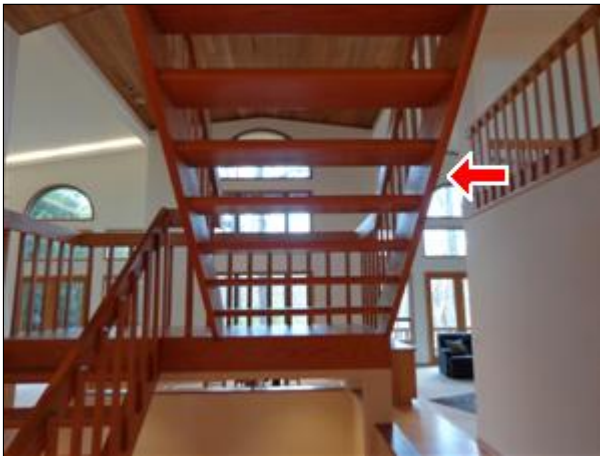
4.3 Picture 1 open spaces

The stairs have open spaces greater than 4" which is no longer permitted by code as they are a hazard to children who can fall thru. Have a general contractor give options on repairs to bring up to current code.

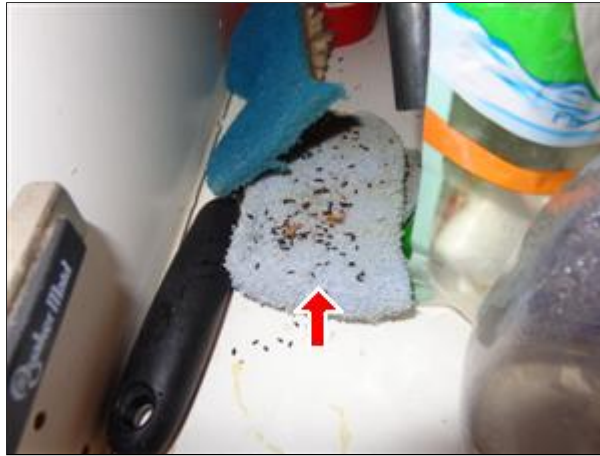
I observed mice droppings in the bottom of the kitchen sink cabinet. The area was recently sealed with foam where pipes come through cabinet. Have this evaluate and seal as needed to stop mice.

4.4 Picture 1 mice feces

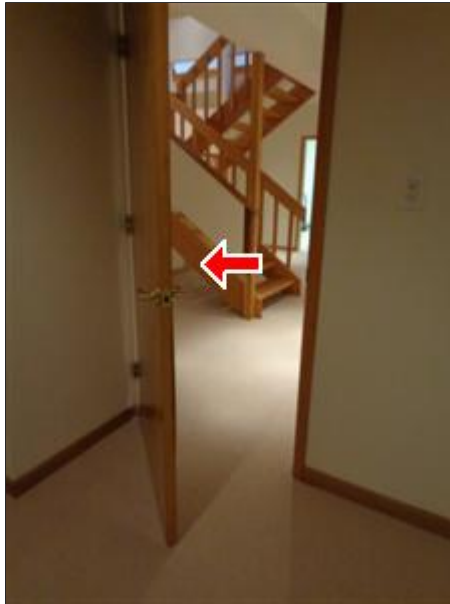
4.5 Picture 1 door wont close easily

(1) Trim adjust the basement door at bottom of stairs basement catch plate to close and latch properly. Also this door is hinge bound and wont close.

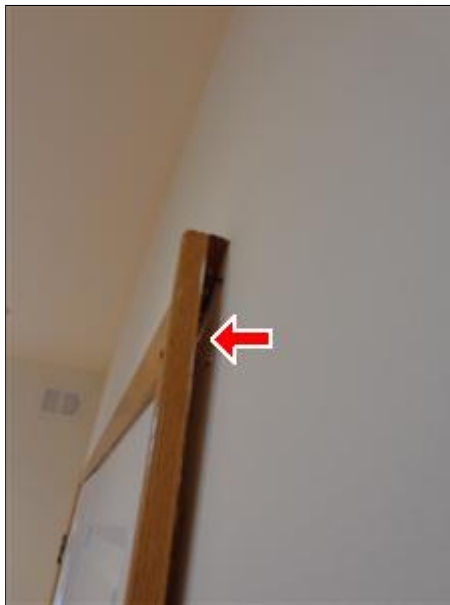
4.5 Picture 2 trim loose

(2) The trim on front door right side is loose have it attached as desired.

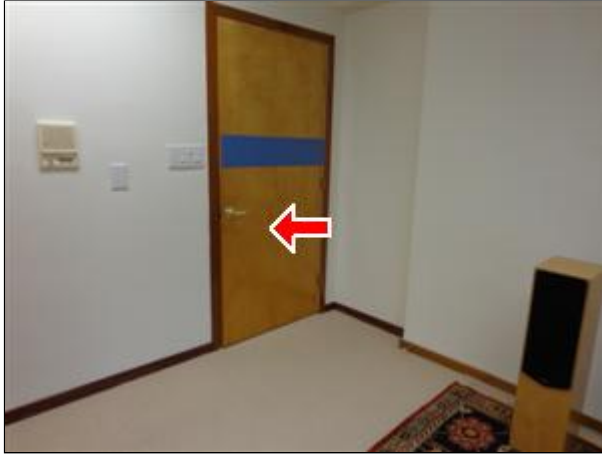
4.5 Picture 3 not meeting catch plate

(3) Trim adjust the basement rear room doors catch plate to close and latch properly.

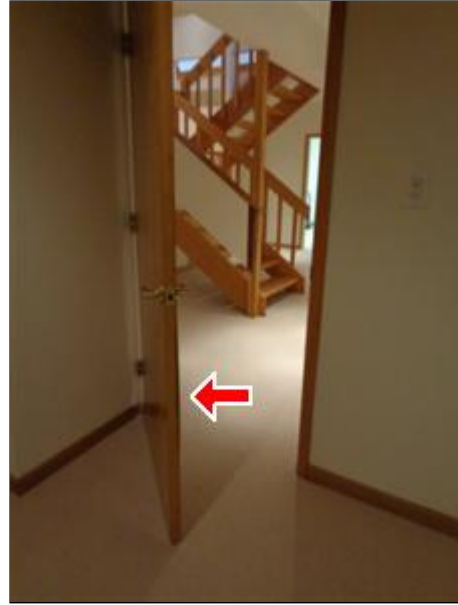
4.5 Picture 4 door de-laminating

Also this door is de-laminating its outer skin have it repaired as needed.

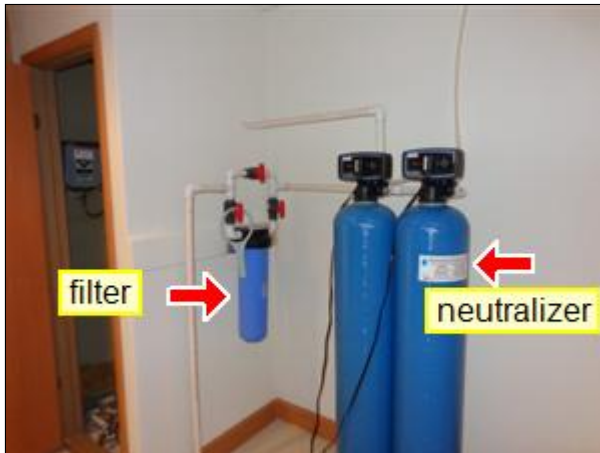
6.0 Picture 1 view of equipment

(1) You have two pieces of water treatment equipment located in the basement. The Neutralizer will require annual maintenance including adding calcium coroset to bring the water from acidic to basic. The unit is operated by an extension cord which is ok but preferred to be hard wire to a receptacle within the room.

In addition, you have a whole house filter that will require replacement periodically depending on the amount of turbidity in the water.

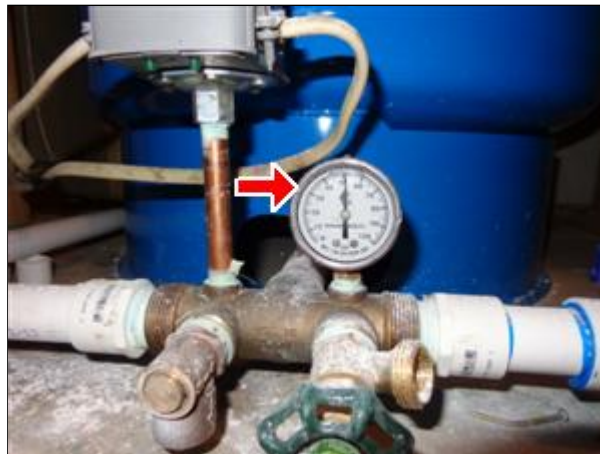
6.0 Picture 3 water in gauge

(2) Some water was observed in the site glass of the pressure gauge which indicates the unit may be leaking. Have this evaluated to determine if this was by design or it needs replacement.

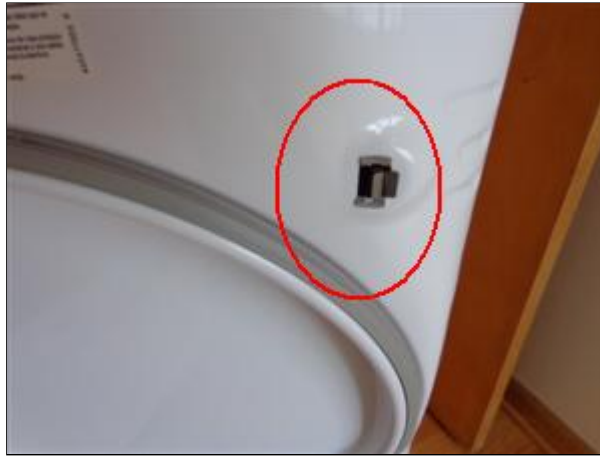
6.0 Picture 4 catch loose in door

(3) The dryer door catch is broken and must be lined up in the middle before door is closed repair as desired.

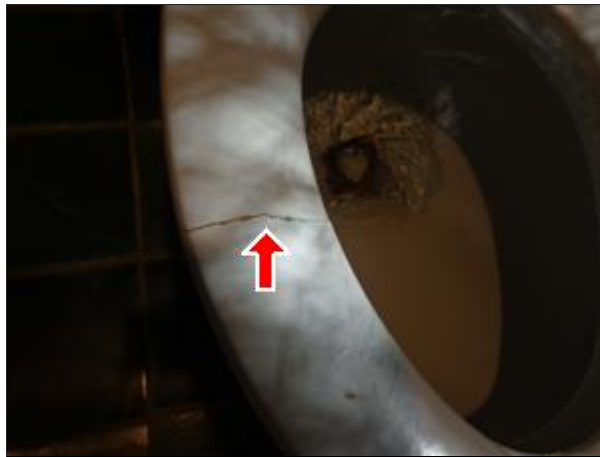
6.0 Picture 5 cracked seat

(4) Replace owners bath toilet seat its broke.

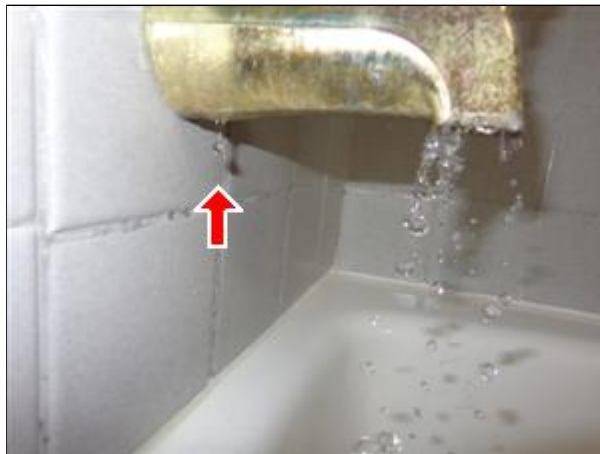
6.0 Picture 6 leaking here

Also the bath diverter is leaking out the bottom in this bathrooms shower replace as needed.

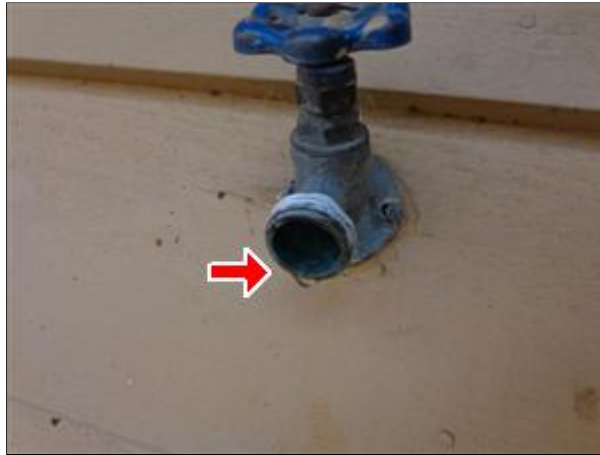
6.0 Picture 7 bib drips

(6) The rear hose bib leaked when turned off. Have a plumber evaluate and repair replace the valve as needed.

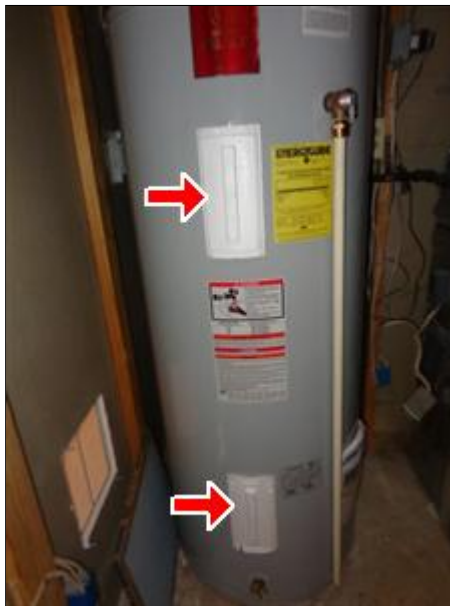
6.1 Picture 1 covers go here and are on top of heater

The covers are off the elements on the water heater. This indicates they may have been repaired recently or an issue existed. Have these elements evaluated and the covers installed.

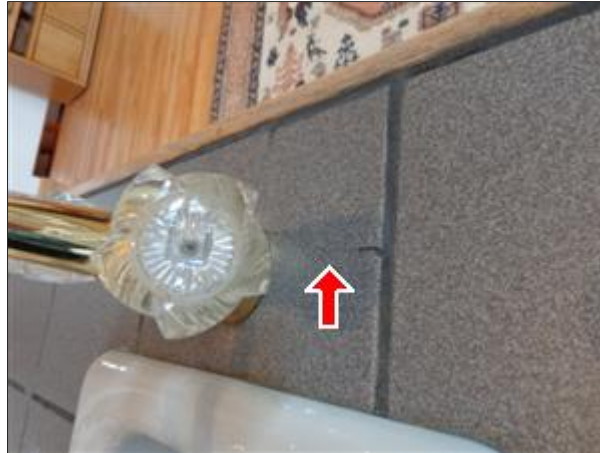
6.6 Picture 1 crack here

(1) The tile at bar sink great room is cracked by the faucet repair as desired.

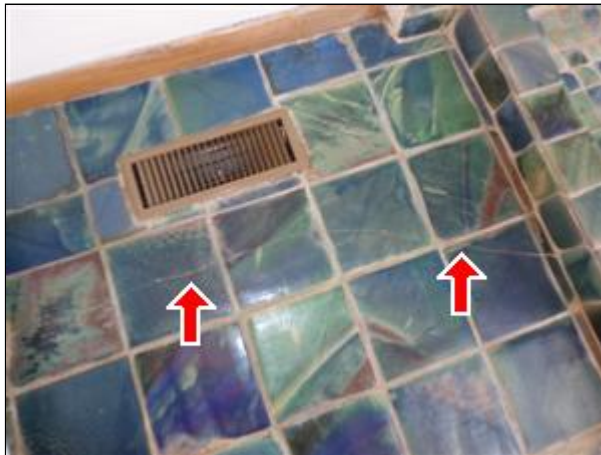
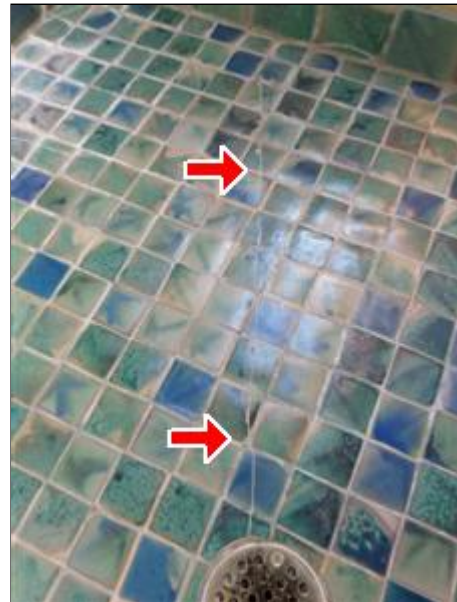
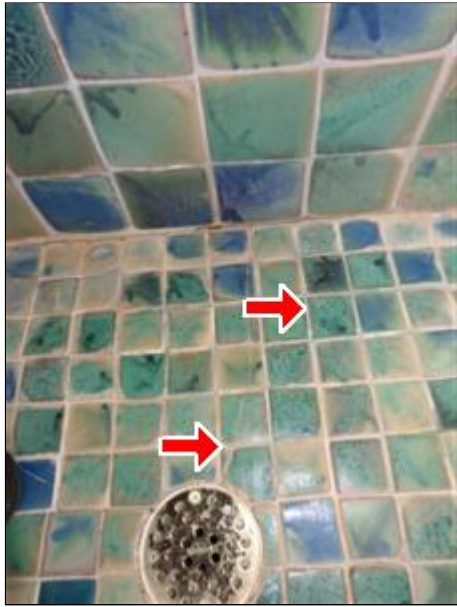
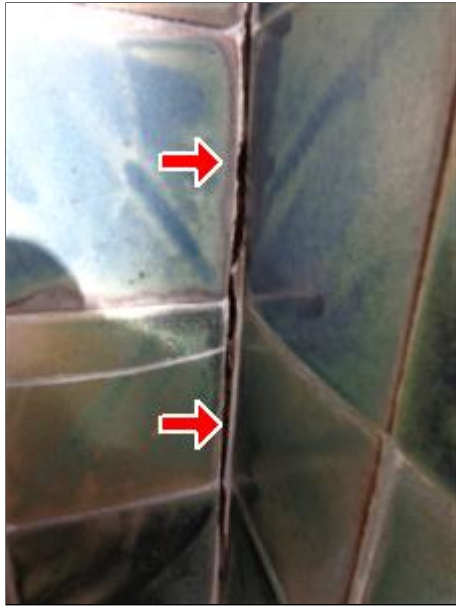
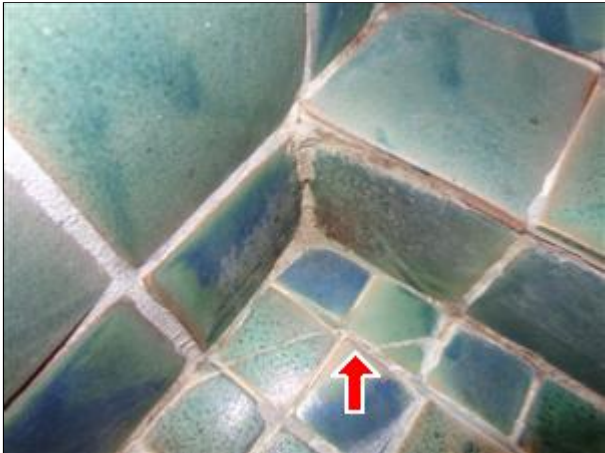
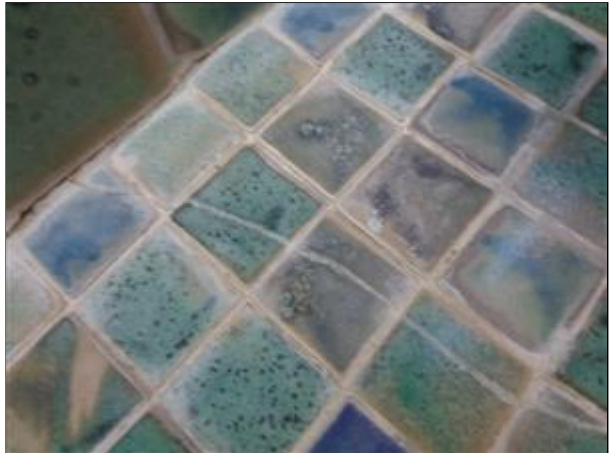
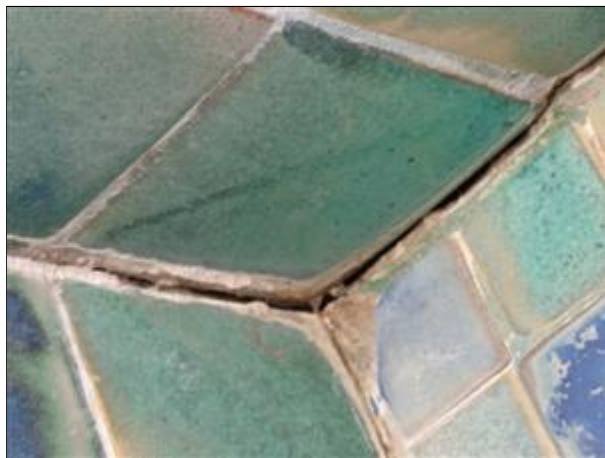
(2) Several of the tile on the shower surround were cracked from settlement. It appears they are large enough to allow water entry behind the wall. Have plumber or tile company repair replace as desired.

The shower pan tile are cracked in the owners bedroom. Cracked tile in this pan can allow water entry below the tile to the lead liner which can leak to ceiling below. Have general contractor repair replace tile as needed.

I was able to read levels of elevated moisture behind the tile with my moisture meter. If water enters behind the tile via voids in grout it can lead to fungal growth and denigrate the backer board. Although we cannot see its condition underneath the tile we will assume it will need replacing when the tile is replaced.

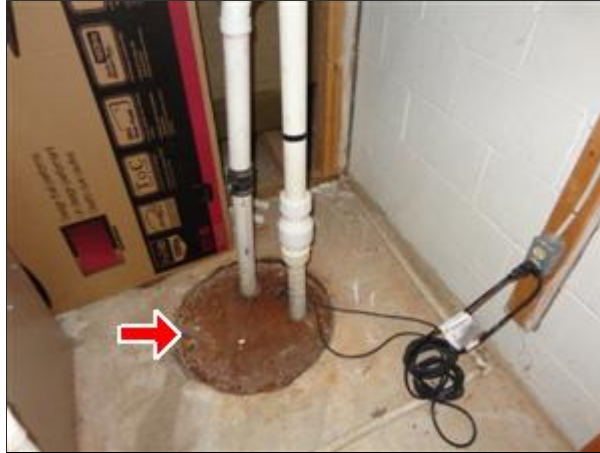
6.7 Picture 1 motor in pit here

(1) Due to the sewer being hung and exiting the home five foot above the floor the entire bathroom group fixtures ie toilet, shower, and bar sink have ejector pumps. These pumps eject the sewage up by mechanical means to gravity feed out to the street. Periodically they need maintenance to prevent odors escaping into the home and mechanical pump can fail.

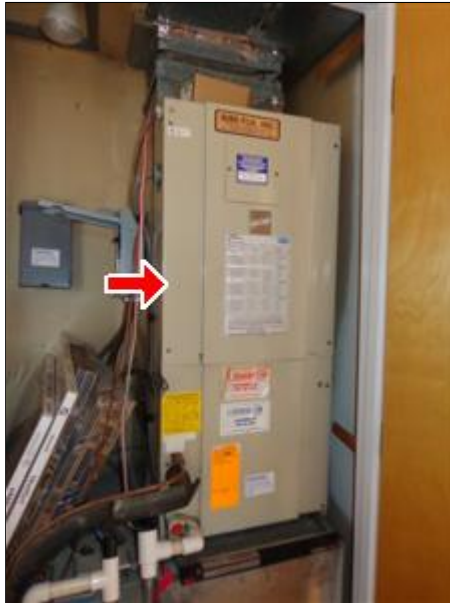
6.7 Picture 2 no overflow pan only safety on trap

(2) It's recommended that when a water producing appliance such as the second floor fan coil unit is installed over conditioned space an overflow pan be installed under the appliance with a drain to a conspicuous location that prevents accidental flooding. I recommend one be installed in this location.

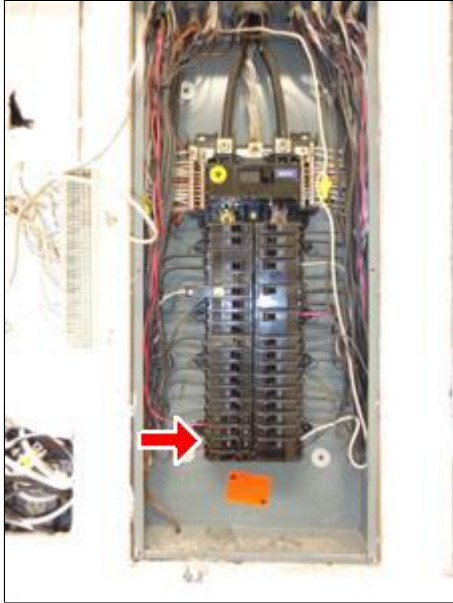
The left most panel second from bottom left side breaker is grounded. When I attempted to turn the breaker back on it trips immediately. Have an electrician evaluate and repair as needed.

7.1 Picture 1 perspective view tripped breaker

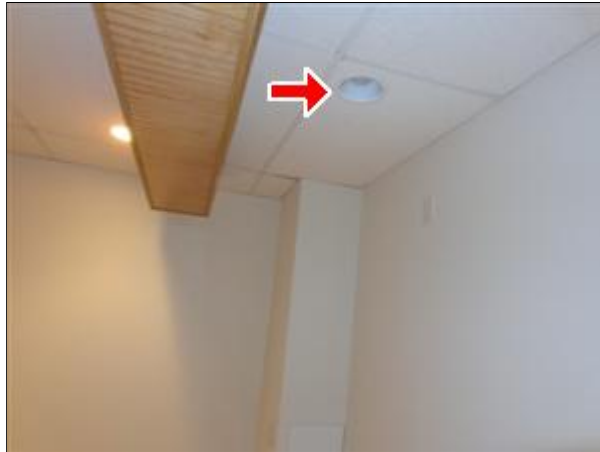
7.3 Picture 1 not working

(1) The lower level recess light in the water treatment room front right was not operational. This could be as simple fix (replace bulb) or a more serious issue requiring a licensed electrician. Have repaired replaced as needed.

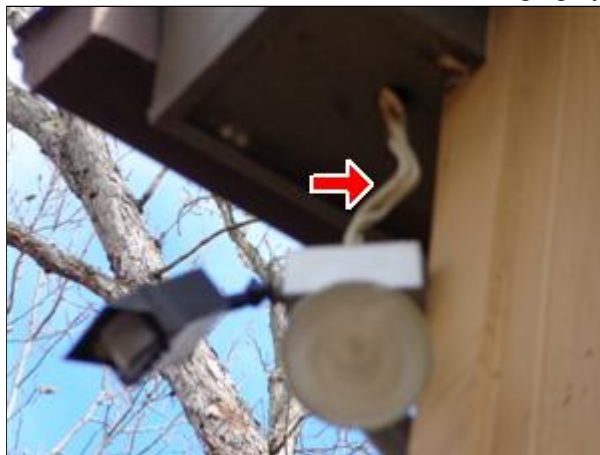
7.3 Picture 2 re-attach here

(2) The upper rear right spot light box came loose from the soffit and is hanging by its wires repair as needed.

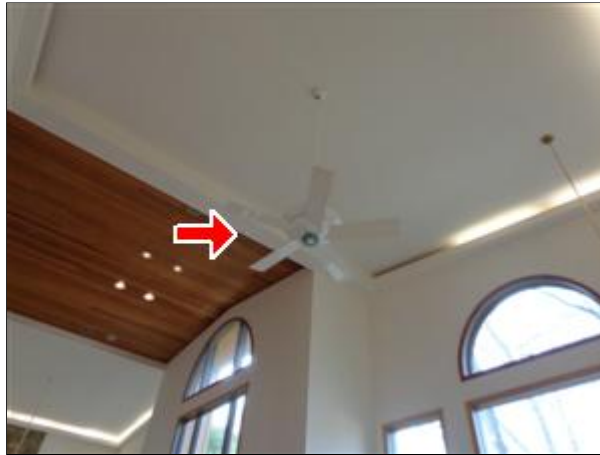
7.3 Picture 3 not working

(3) Both ceiling fan lights were not operational. This could be as simple fix (replace bulb) or a more serious issue requiring a licensed electrician. Have repaired replaced as needed.

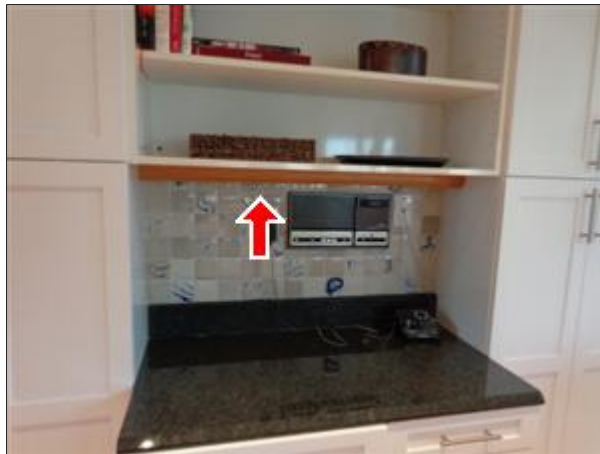
7.3 Picture 4 light not working

(4) The desk area fluorescent light was not operational. This could be as simple fix (replace bulb) or a more serious issue requiring a licensed electrician. Have repaired replaced as needed.

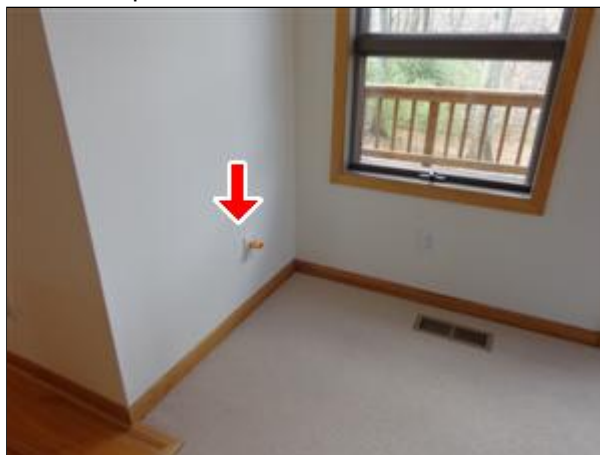
7.4 Picture 1 no power

The outlet in left side great room was tested and no power was present. Its possible this is on a switch I could not locate. Have an electrician evaluate and repair as needed.

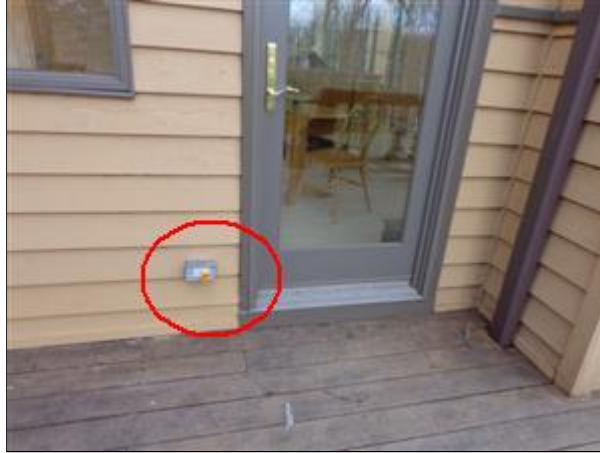
7.5 Picture 1 no cover

The outside rear right receptacle is missing its cover replace as needed.

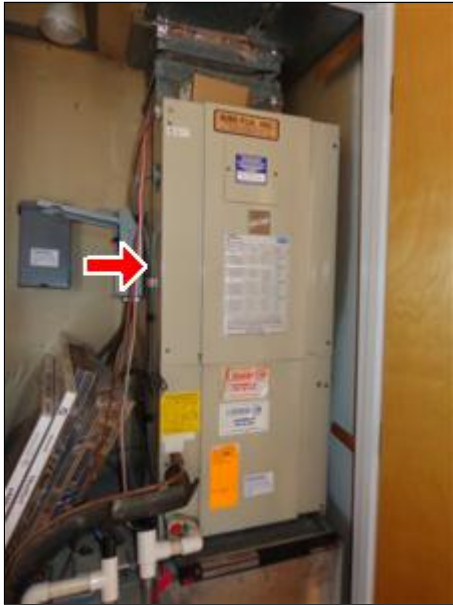
8.0 Picture 1 zone 2 second floor

The Heat Pump Zone 2 is 24 years old and is nearing the end of its typical life. Some units last longer than average useful life and some less. Budget to replace in near future.

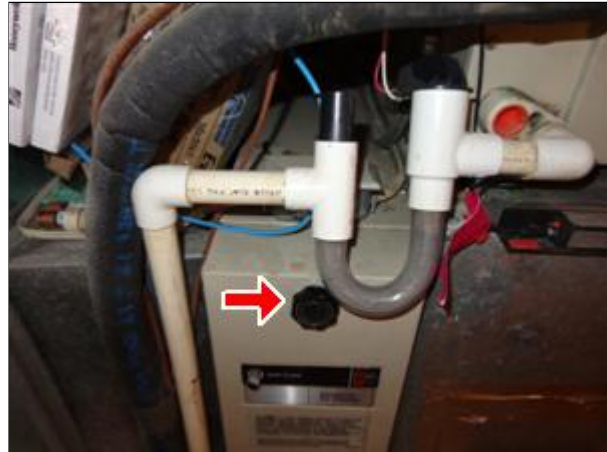
8.0 Picture 2 filter door blocked

The electronic air filter access door is blocked by the condensate trap however the cells were found in the closet of bedroom and obviously this is not being used as a filter is below the unit.

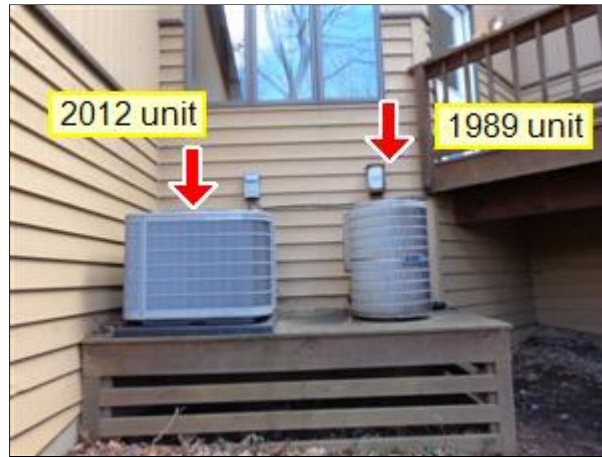
8.0 Picture 5 older unit

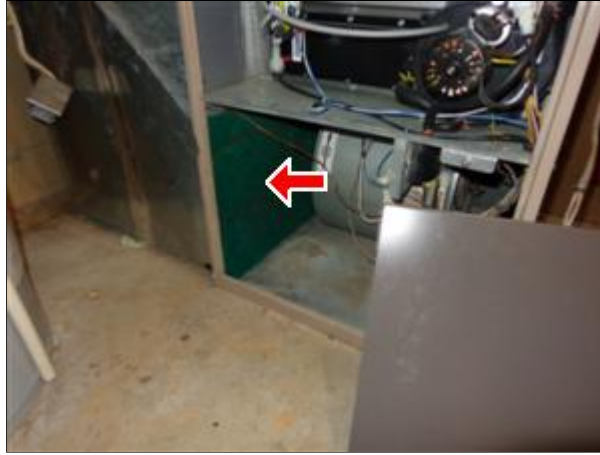
8.1 Picture 1 filter here

(1) The basement zone gas furnace has a washable filter in the blower compartment that must be cleaned and maintained periodically.

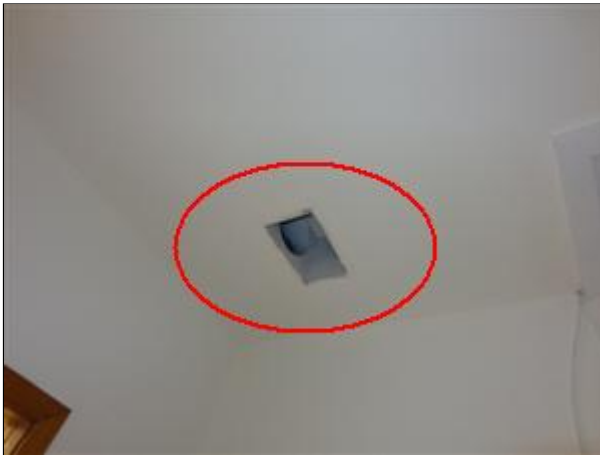
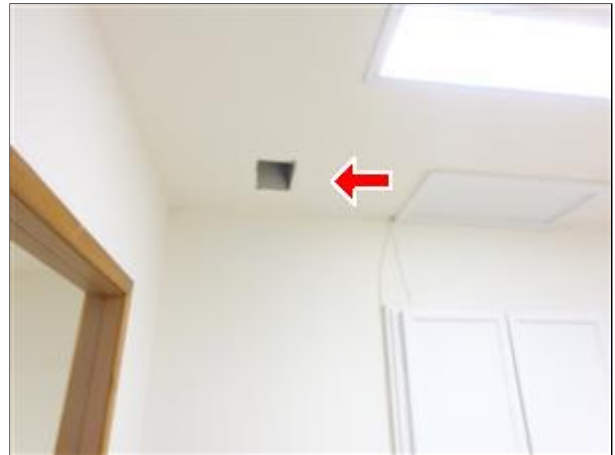
8.1 Picture 2 no register

(2) The basement rear left room is missing a register on the ceiling supply have it installed as needed.

8.1 Picture 3 perspective view above panel

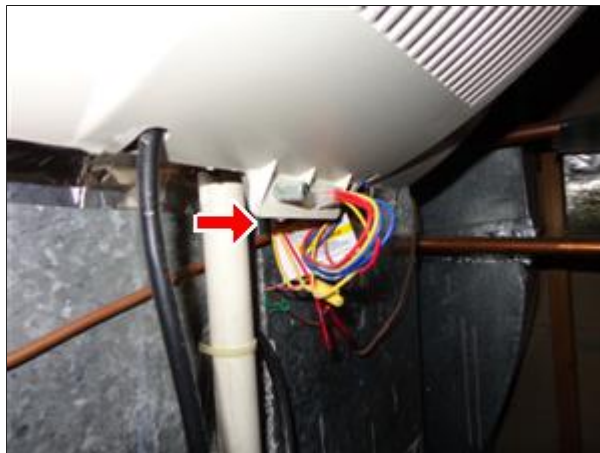
8.1 Picture 4 leaking here

(3) The humidifier was functional but needs to be serviced and a new filter installed for top performance. The unit was leaking slightly when tested from the bottom of the unit. Have this evaluated when filter is replaced.

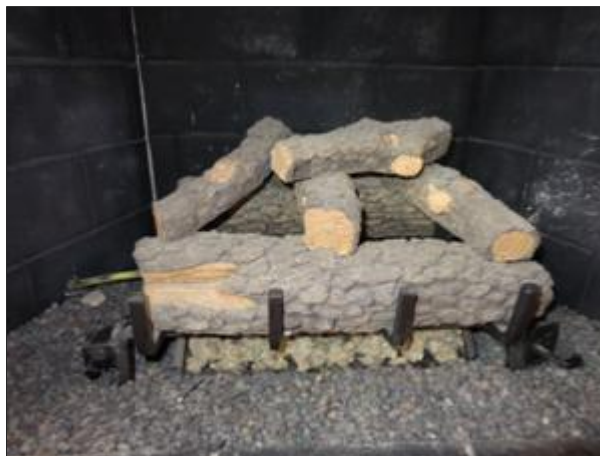
(1) I was unable to get the gas log set on right side great room off kitchen to stay lit have them evaluated and repaired replaced as needed.

8.4 Picture 1 not working

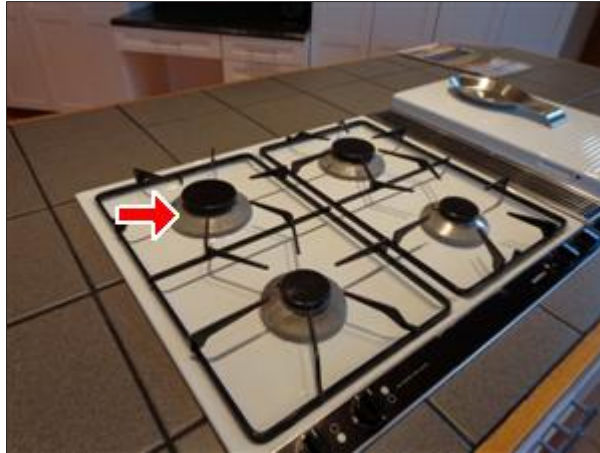
10.1 Picture 1 not lighting

The left rear stove burner wont light. Have an appliance company evaluate and repair/replace as needed.

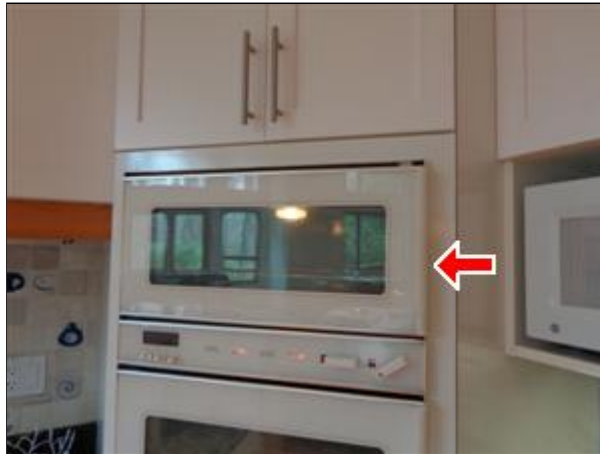
10.4 Picture 1 hinge sag

I had to lift up on the microwave/oven door to get this unit to close and latch properly. Repair as desired.
